2008 Isuzu Ascender LS

2008 Driveline/Axle Front Drive Axle - Ascender, Envoy & Trailblazer

SPECIFICATIONS

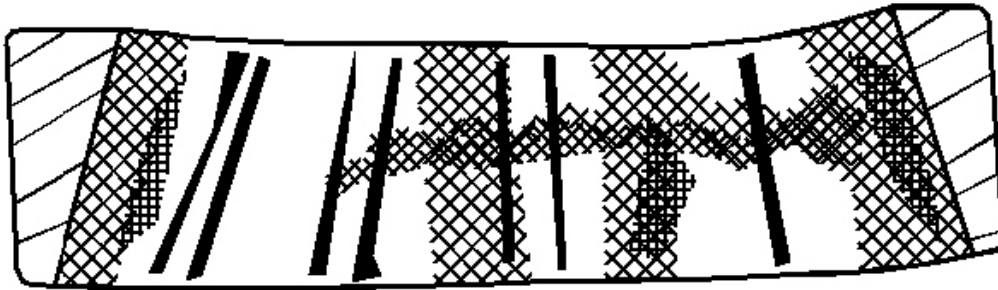
Fig. 25: Inspecting Bearing Rollers & Races For Pitting, Grooves, Spalling & Excessive Wear
Courtesy of GENERAL MOTORS CORP.

Flaked surface metal that results from fatigue. Replace the bearing. Clean all related parts.
