2006 Buick Rainier
2006 Driveline/Axle Wheel Drive Shafts - Ascender, Envoy, Rainier & TrailBlazer

2006 Driveline/Axle

Wheel Drive Shafts - Ascender, Envoy, Rainier & TrailBlazer

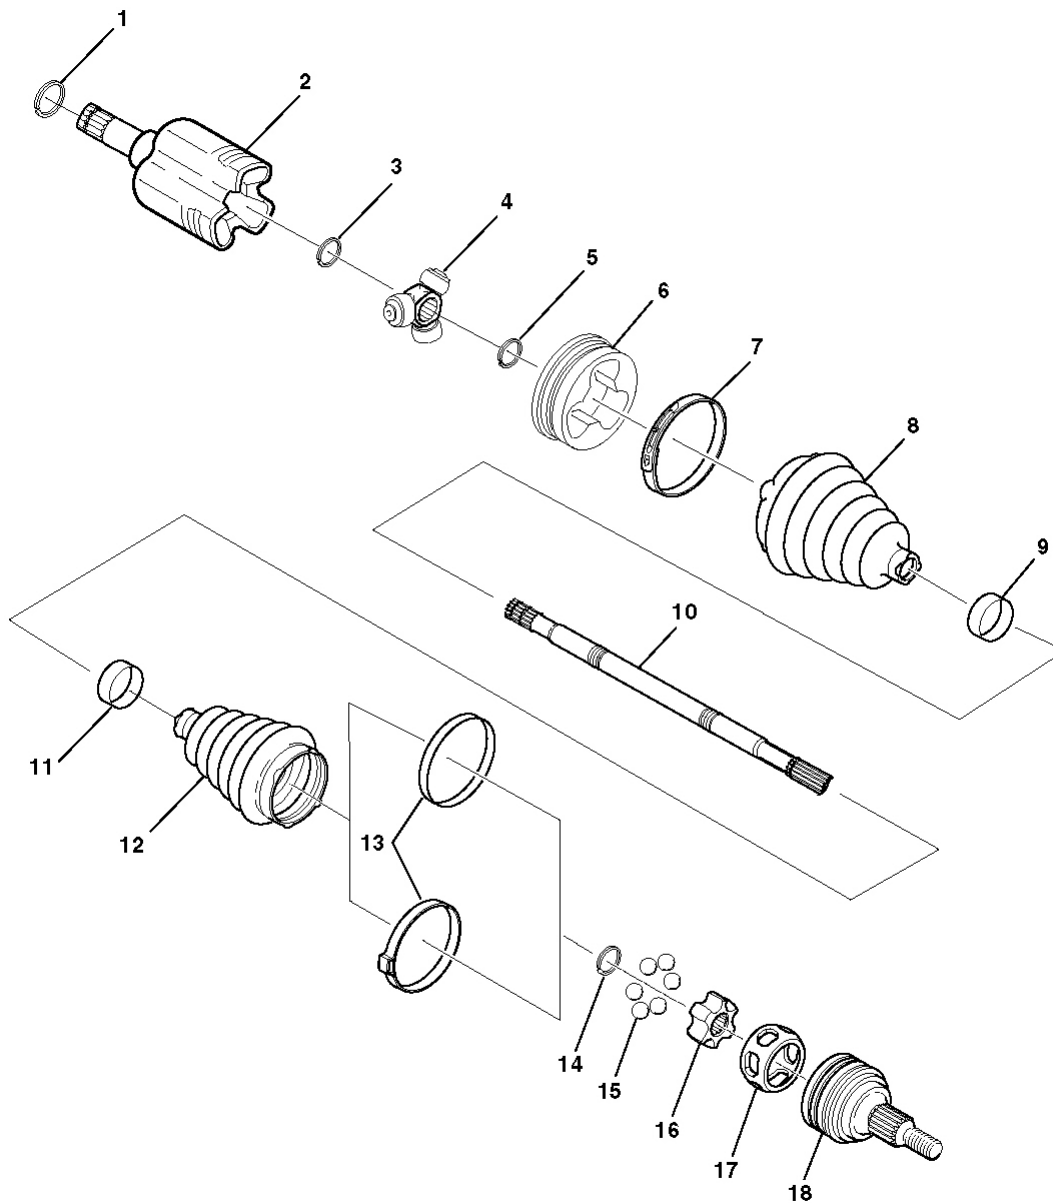
Fig. 1: Halfshaft Disassembled View
Courtesy of GENERAL MOTORS CORP.

Callout	Component Name
1	Differential Shaft Ring
2	Tripot Housing Assembly

3	Spacer Ring
4	Tripot Joint Spider Assembly
5	Spacer Ring
6	Tripot Bushing
7	Boot Retaining Clamp
8	Tripot Joint Boot
9	Halfshaft Swage Ring
10	Halfshaft Bar
11	Halfshaft Swage Ring
12	CV Joint Boot
13	Swage Ring/Clamp
14	Race Retaining Ring
15	Ball
16	CV Joint Inner Race
17	CV Joint Cage
18	CV Joint Outer Race

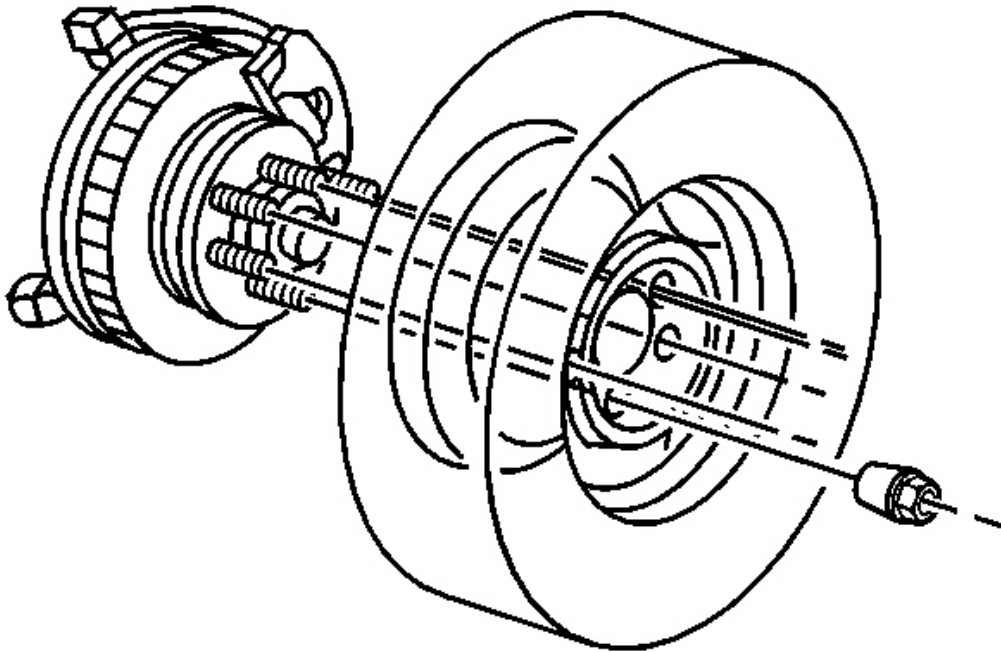
Fig. 2: View Of Tire/Wheel Assembly, Hub Assembly & Wheel Nuts
Courtesy of GENERAL MOTORS CORP.

1. Raise the vehicle. Refer to **Lifting and Jacking the Vehicle** in General Information.
2. Remove the tire and wheel assembly. Refer to **Tire and Wheel Removal and Installation** in Tires and Wheels.

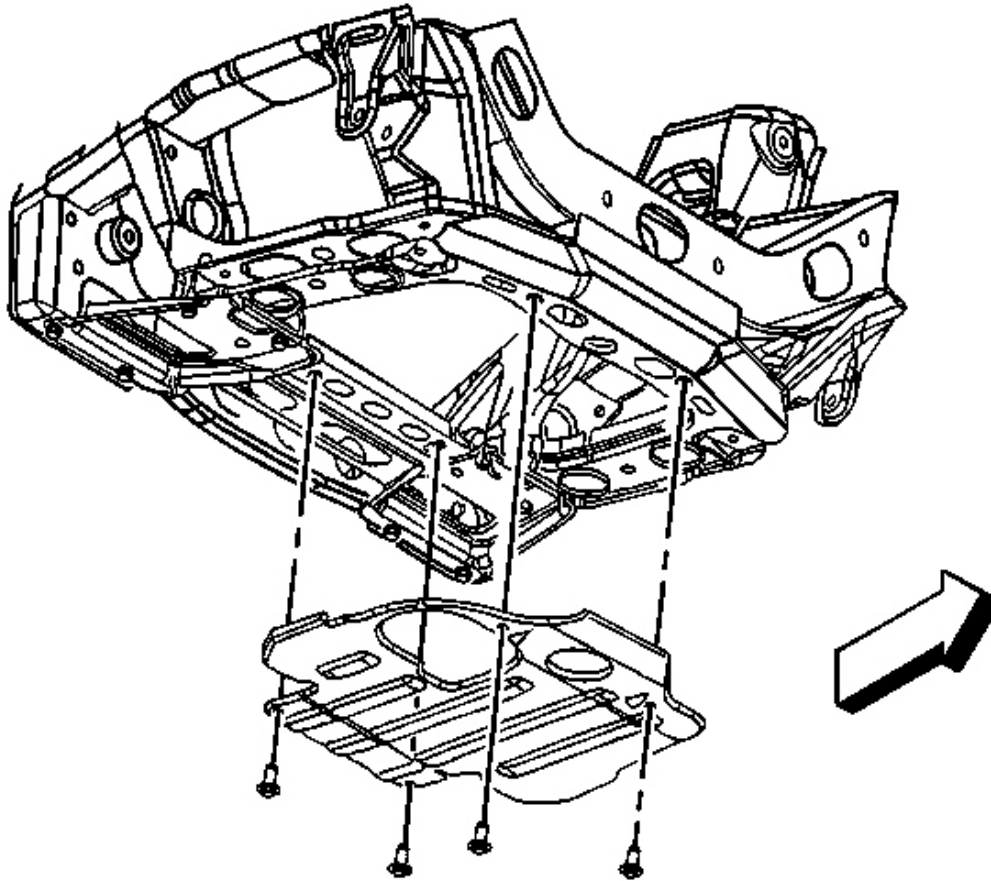
Fig. 3: Removing/Installing Engine Shield
Courtesy of GENERAL MOTORS CORP.

3. Remove the engine protection shield. Refer to **Engine Protection Shield Replacement** in Frame and Underbody.

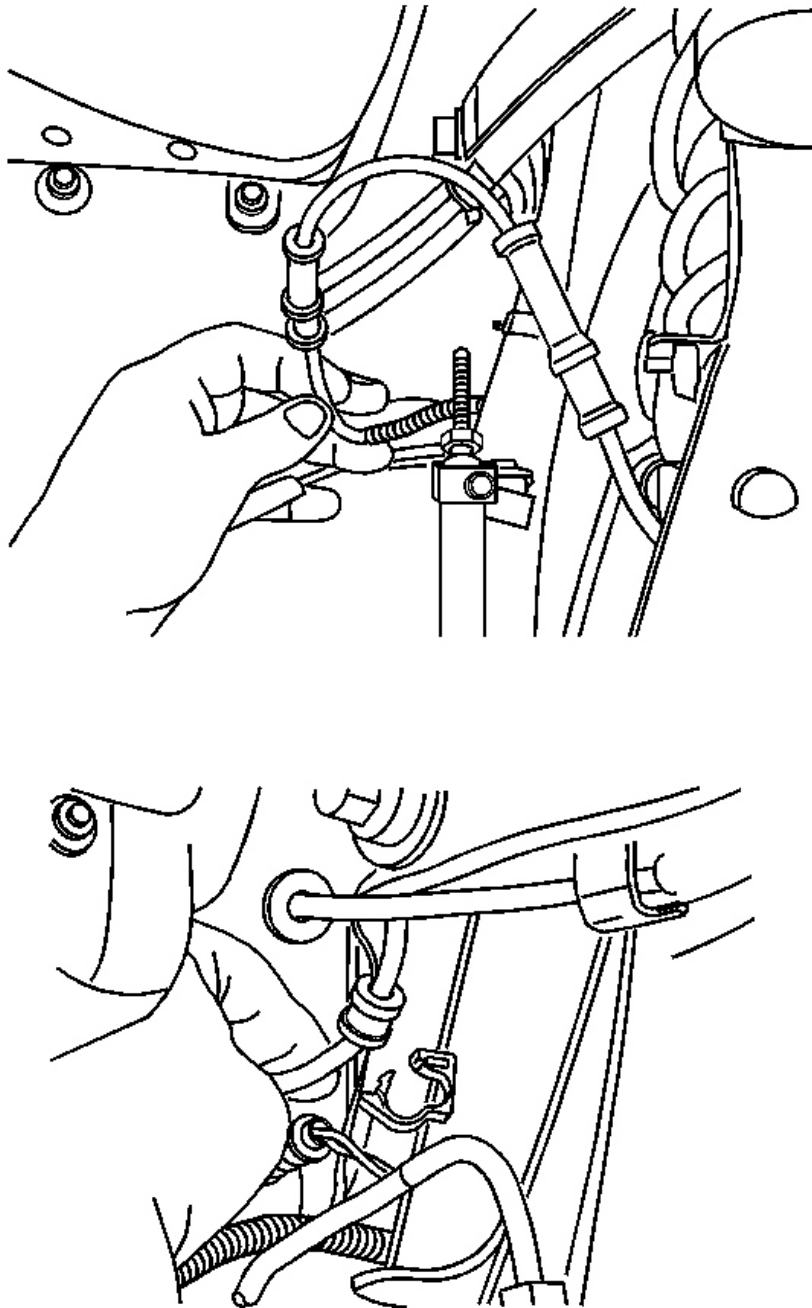
Fig. 4: Identifying Wheel Speed Sensor Wiring Harness
Courtesy of GENERAL MOTORS CORP.

4. Remove the wheel speed sensor wiring harness from the retainers.

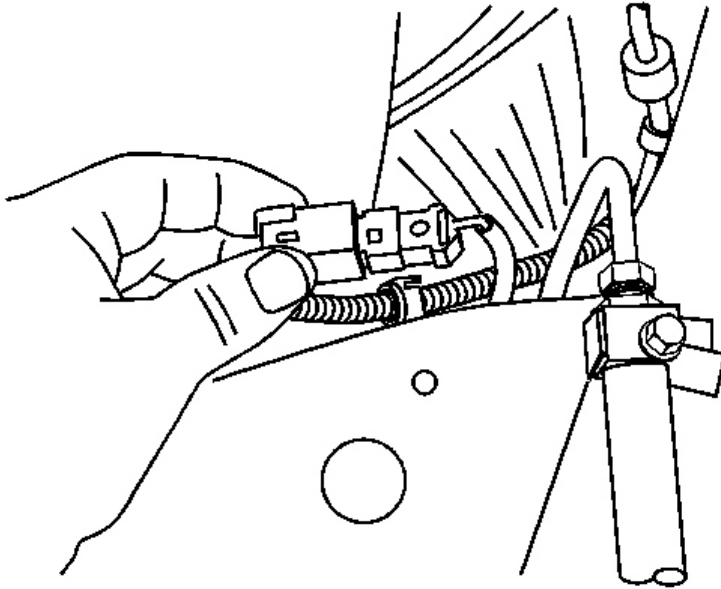
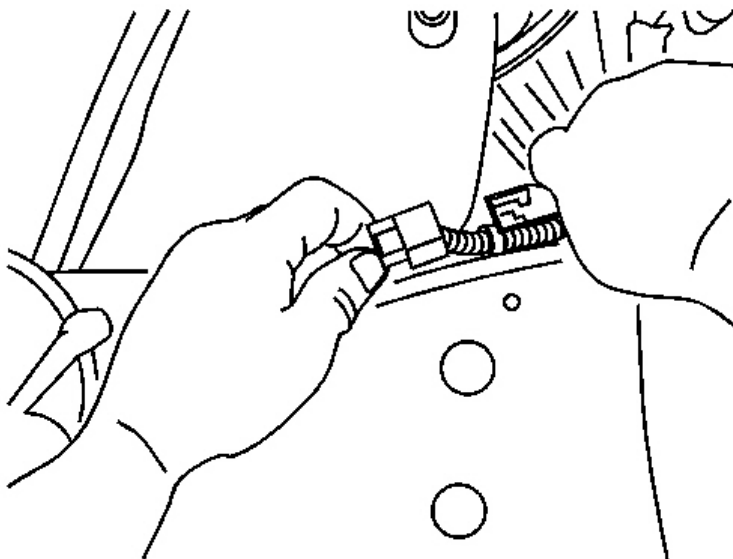
Fig. 5: Locating Connector

5. Disconnect the wheel speed sensor from the harness.

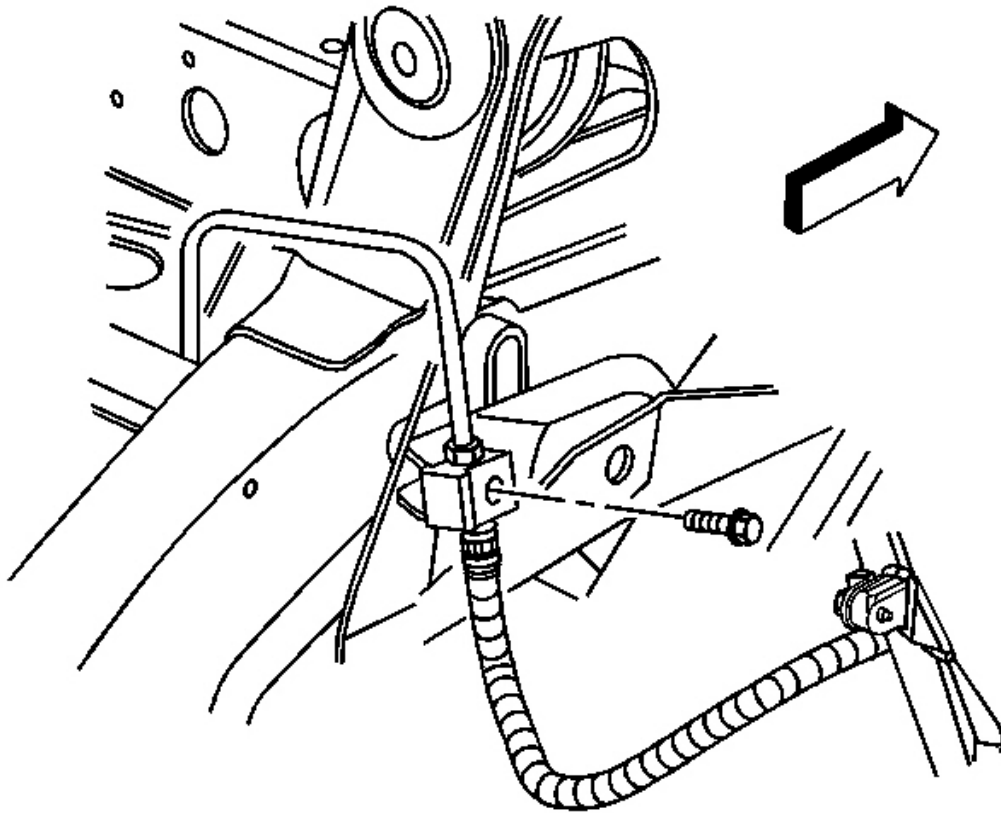
Fig. 6: Front Brake Hose Retaining Bolt
Courtesy of GENERAL MOTORS CORP.

6. Remove the retaining bolt for the front brake hose.

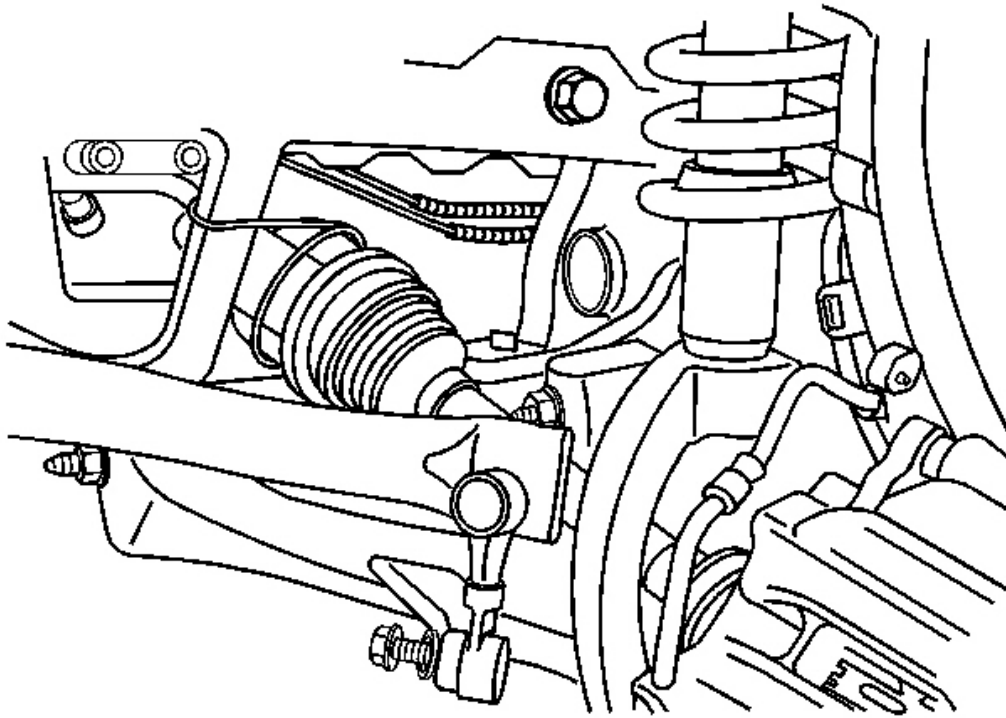
Fig. 7: Lower Control Arm View
Courtesy of GENERAL MOTORS CORP.

7. Remove the front stabilizer bar link from the lower control arm. Refer to **Stabilizer Shaft Link Replacement** in Front Suspension.

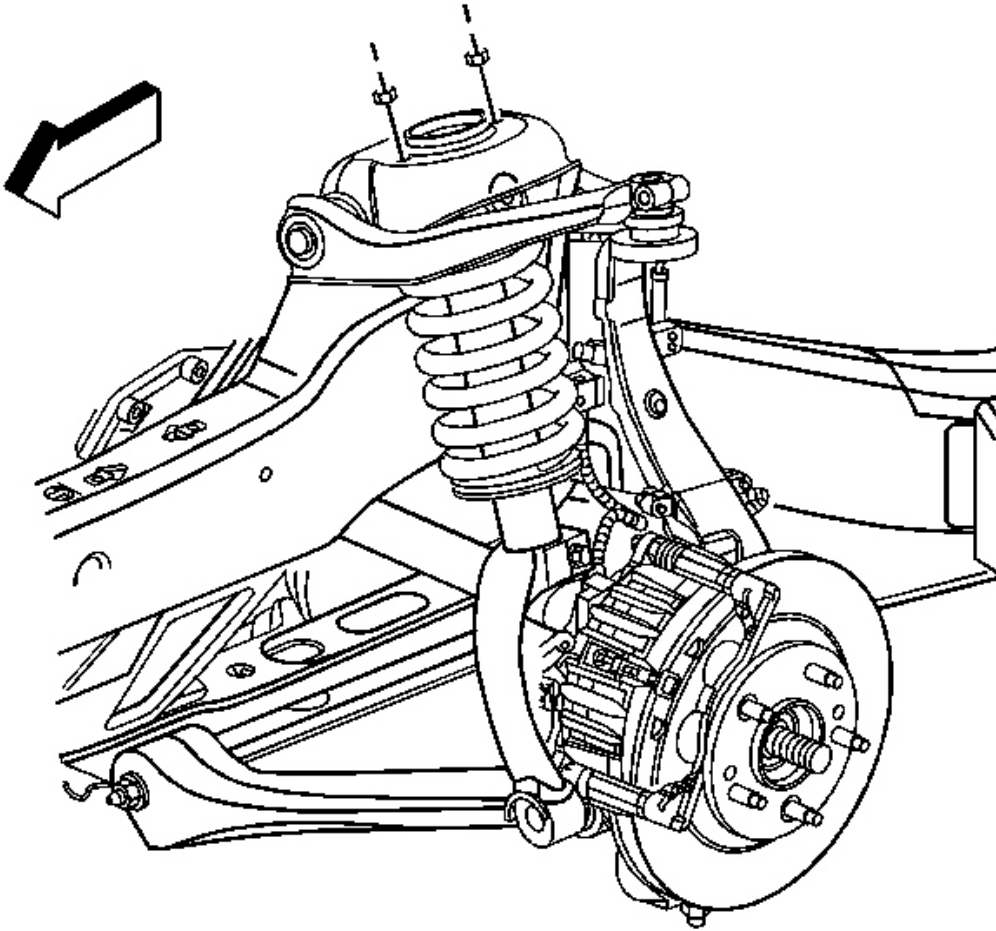
Fig. 8: Upper Shock Module View
Courtesy of GENERAL MOTORS CORP.

8. Remove the upper shock module retaining from the shock tower.

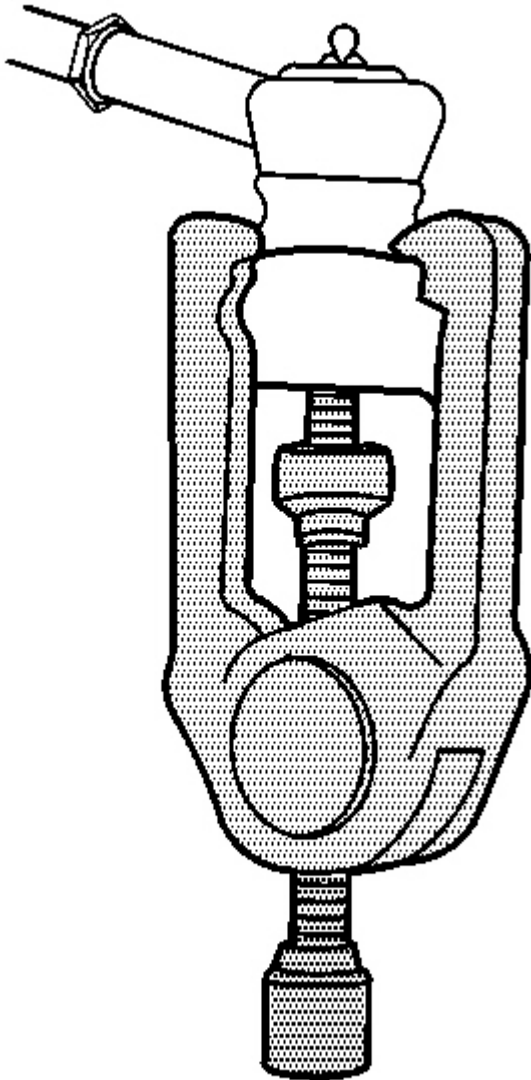
Fig. 9: Removing Outer Tie Rod Assembly From Steering Knuckle
Courtesy of GENERAL MOTORS CORP.

9. Remove the tie rod end from the steering knuckle. Refer to **Rack and Pinion Outer Tie Rod End Replacement** in Power Steering System.

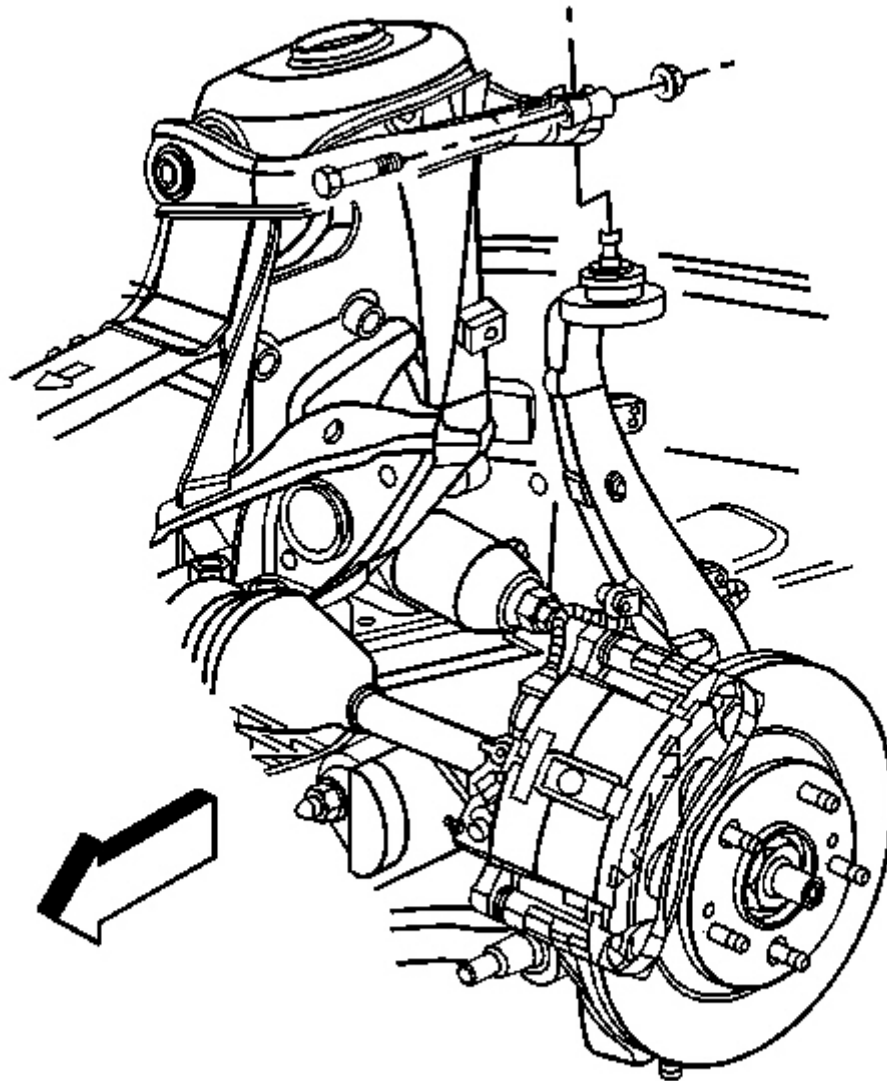
Fig. 10: View Of Upper Control Arm To The Steering Knuckle Pinch Bolt And Nut
Courtesy of GENERAL MOTORS CORP.

10. Remove the left and right upper ball joint pinch bolt and nut.
11. Remove the shock module from the shock tower.
12. Remove the steering knuckle from the upper control arm.
13. Remove the front wheel drive axle from the steering knuckle.

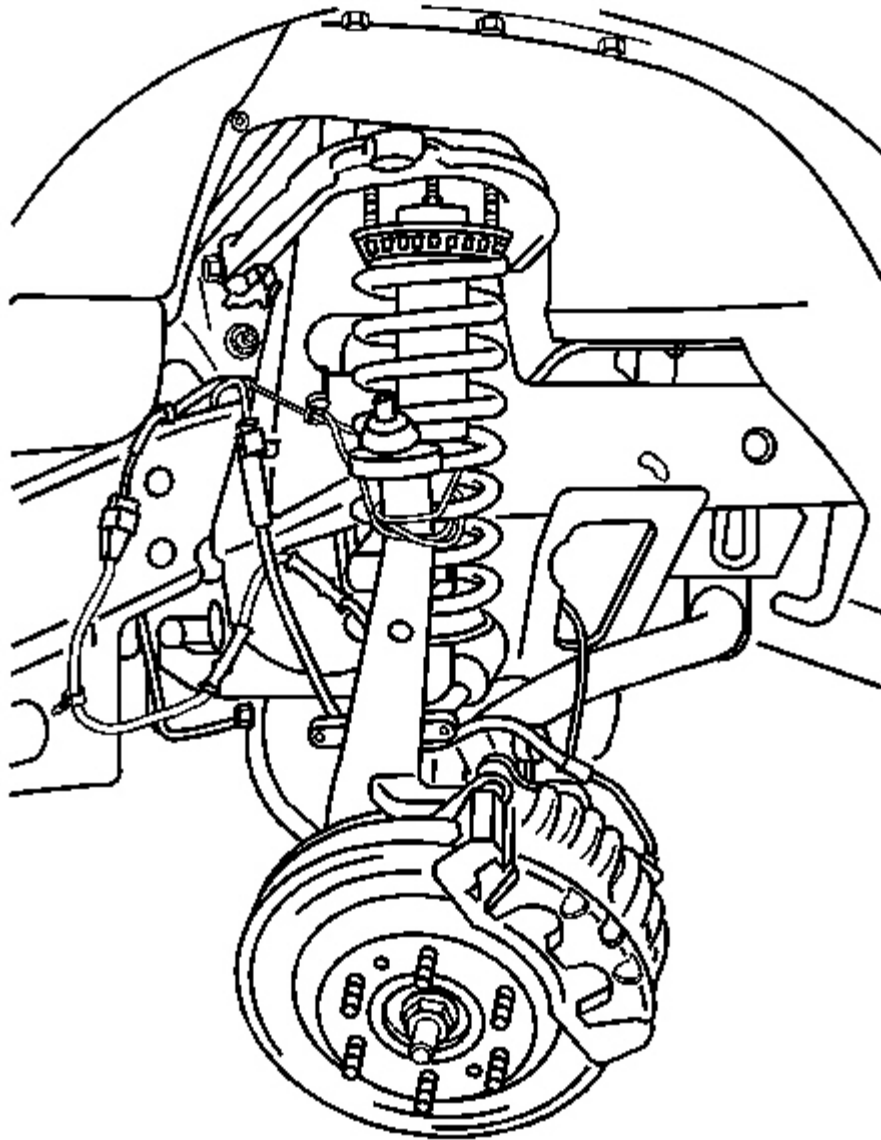
Fig. 11: View Of Shock Module/Steering Knuckle
Courtesy of GENERAL MOTORS CORP.

14. Using mechanics wire or hook, support the front shock module/steering knuckle to the frame.

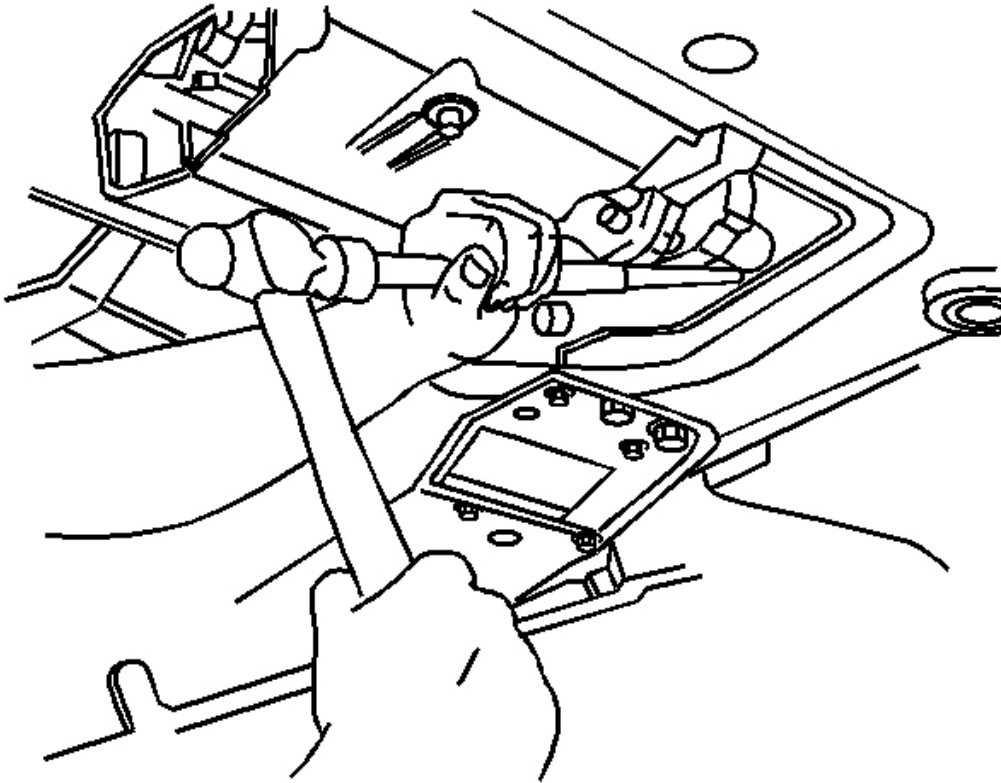
Fig. 12: Removing Left Side Wheel Drive Shaft
Courtesy of GENERAL MOTORS CORP.

15. Disconnect the left side wheel drive shaft from the differential carrier assembly by placing a brass drift against the tripot housing. Firmly strike the brass drift outward from the case with a hammer. Strike hard enough to overcome the snap ring pressure holding in the shaft.

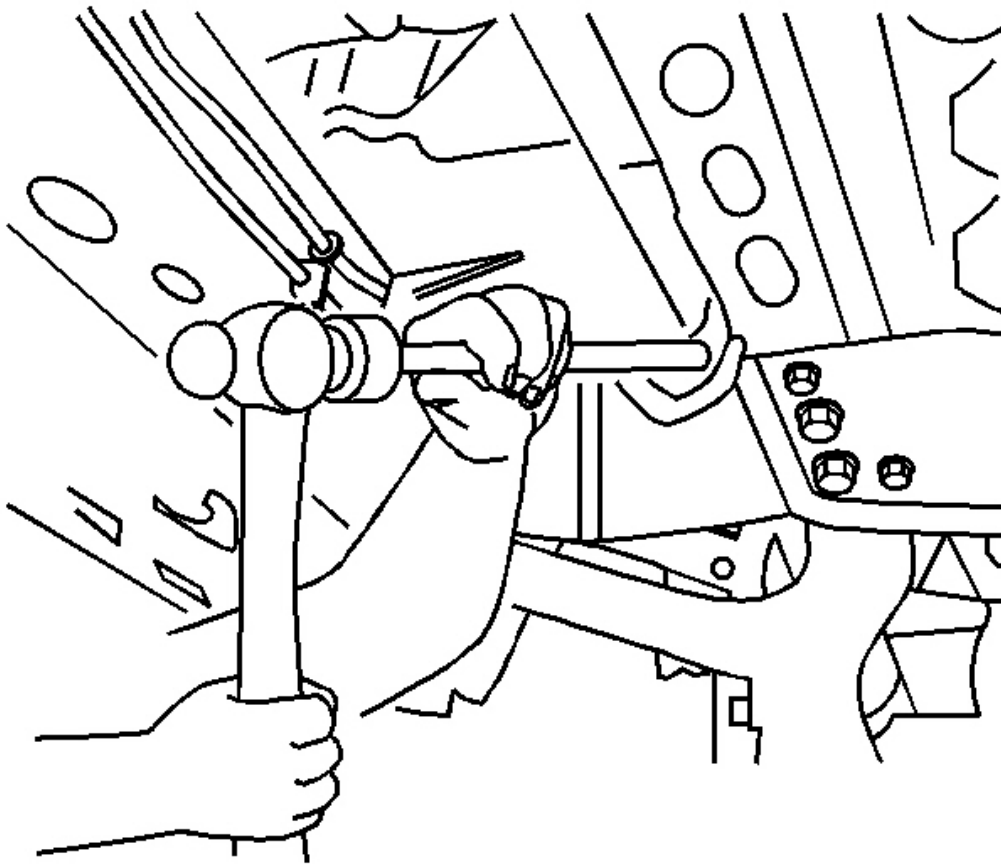
Fig. 13: Removing Right Side Wheel Drive Shaft
Courtesy of GENERAL MOTORS CORP.

16. Disconnect the right side wheel drive shaft from the clutch fork housing assembly by placing a brass drift against the tripot housing. Firmly strike the brass drift outward from the case with a hammer. Strike hard enough to overcome the snap ring pressure holding in the shaft.
17. Pull the wheel drive shaft straight out from the differential carrier assembly or the clutch fork housing assembly.
18. Remove the wheel drive shaft.

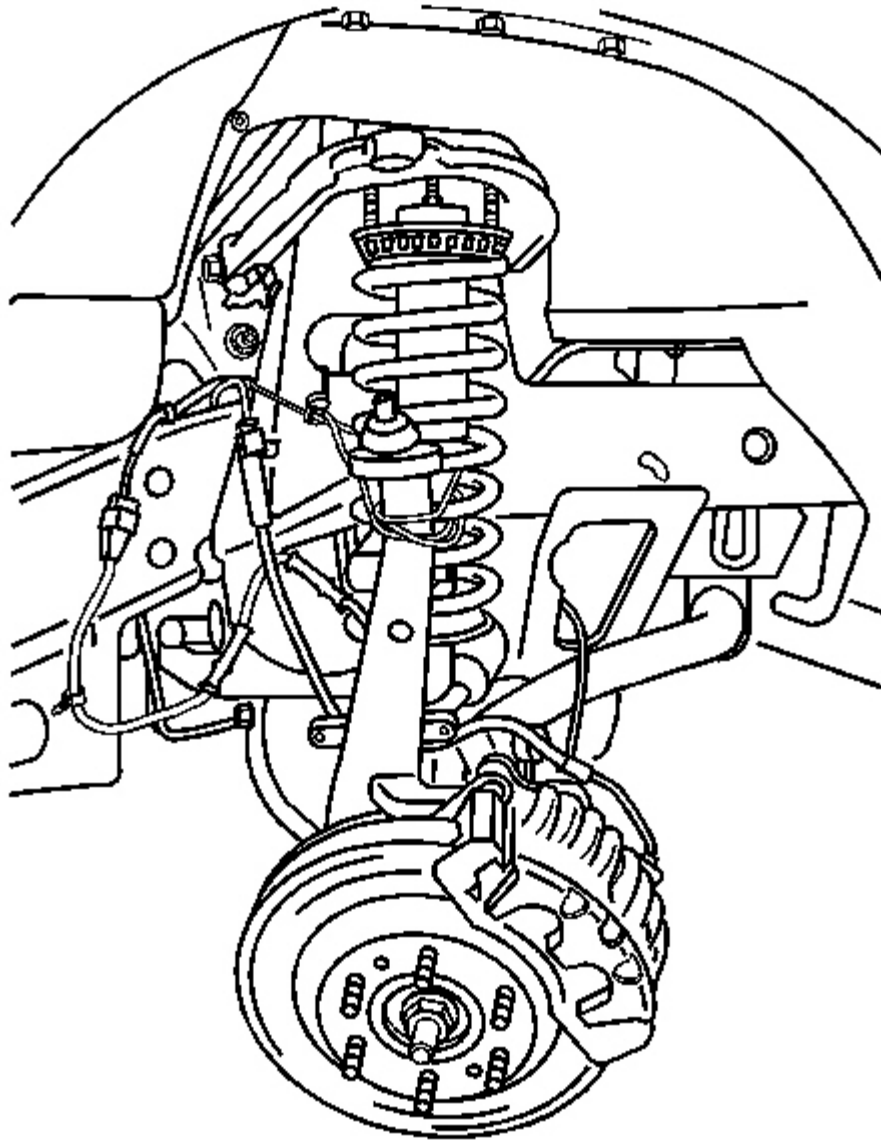
Fig. 14: View Of Shock Module/Steering Knuckle
Courtesy of GENERAL MOTORS CORP.

1. Install the front wheel drive axle front differential assembly.
2. Remove the mechanics wire or hook from the front shock module/steering

3. Install the front wheel drive axle in the steering knuckle.
4. Position the shock module in the shock tower.
5. Install the shock module into the shock tower
6. Install the upper ball joint in the upper control arm.

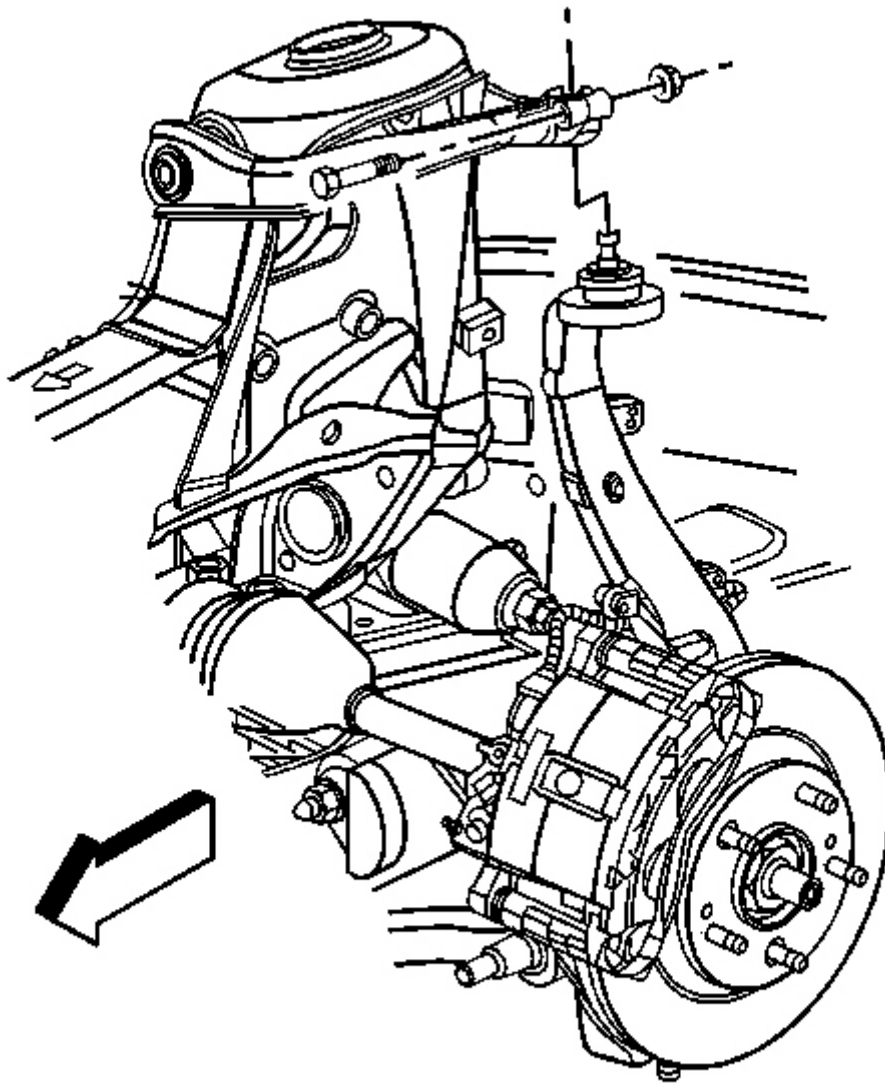
Fig. 15: View Of Upper Control Arm To The Steering Knuckle Pinch Bolt And Nut

7. Install the pinch bolt and nut. For the proper torque specification, refer to **Steering Knuckle Replacement (RWD)** or **Steering Knuckle Replacement (4WD)** in Front Suspension.

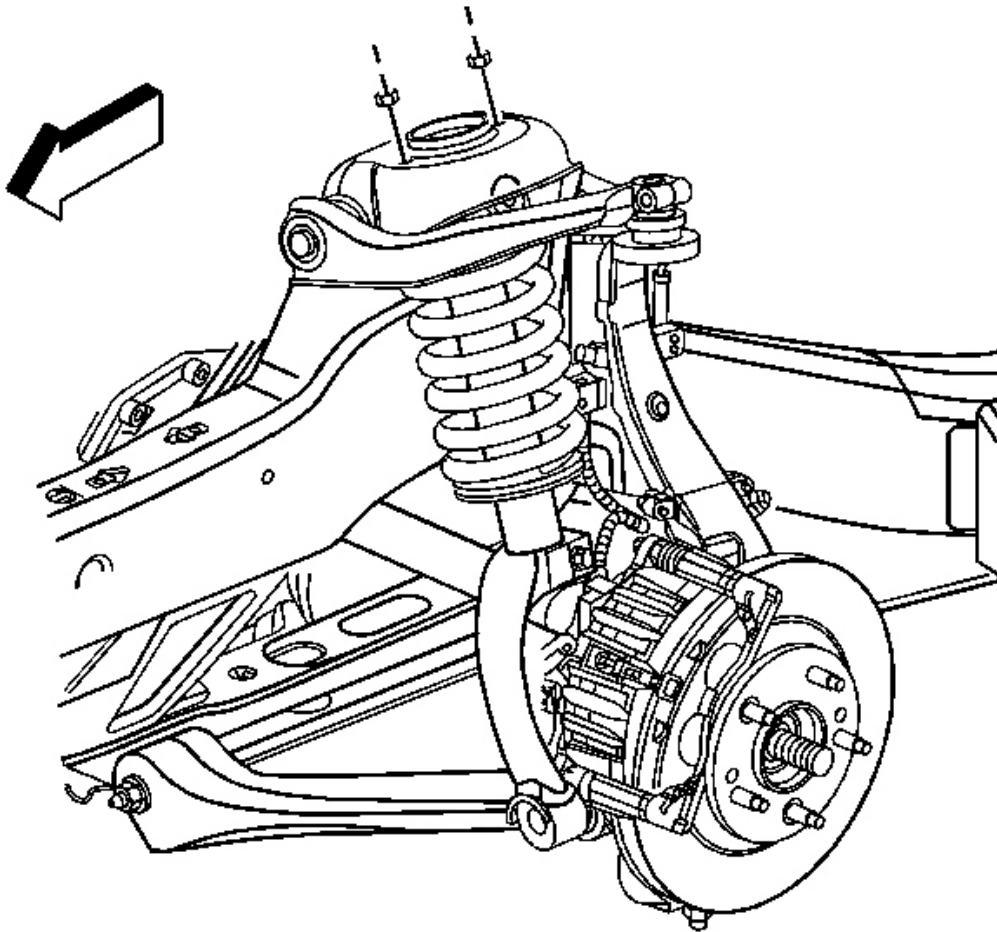
Fig. 16: Upper Shock Module View
Courtesy of GENERAL MOTORS CORP.

8. Install the shock module retaining nuts. For the proper torque specification, refer to **Shock Module Replacement** in Front Suspension.
9. Install the front wheel drive shaft retaining.

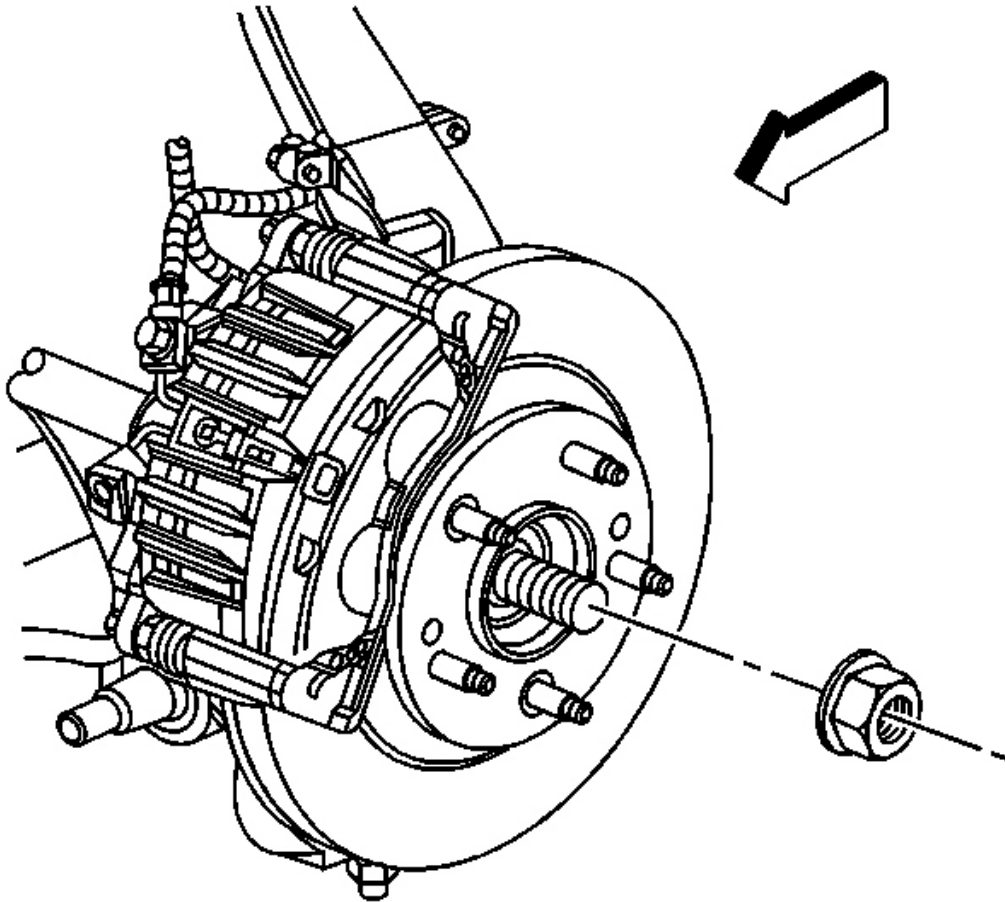
Fig. 17: Removing/Installing Wheel Drive Shaft Nut
Courtesy of GENERAL MOTORS CORP.

10. Install the new front wheel drive shaft retaining nut.

Tighten: Tighten the wheel drive shaft retaining nut to 140 N.m (103 lb ft).

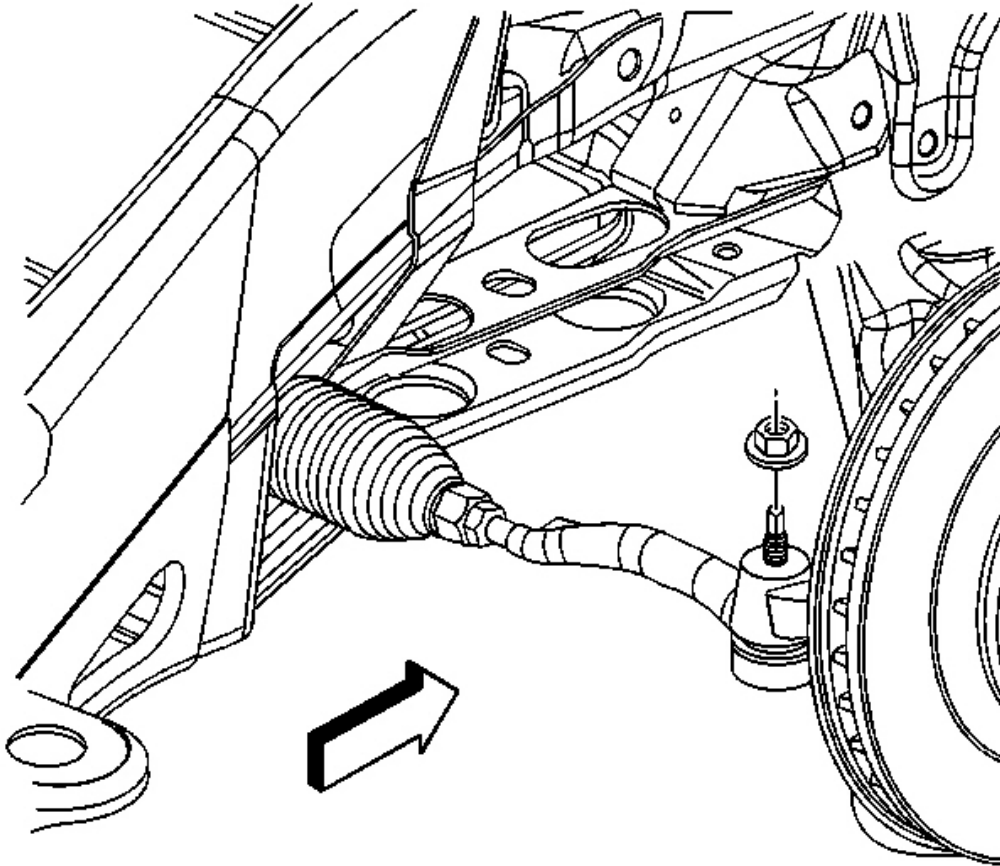
Fig. 18: View Of Tie Rod Retaining Nut
Courtesy of GENERAL MOTORS CORP.

11. Install the tie rod end in the steering knuckle. Refer to **Rack and Pinion Outer Tie Rod End Replacement** in Power Steering System.

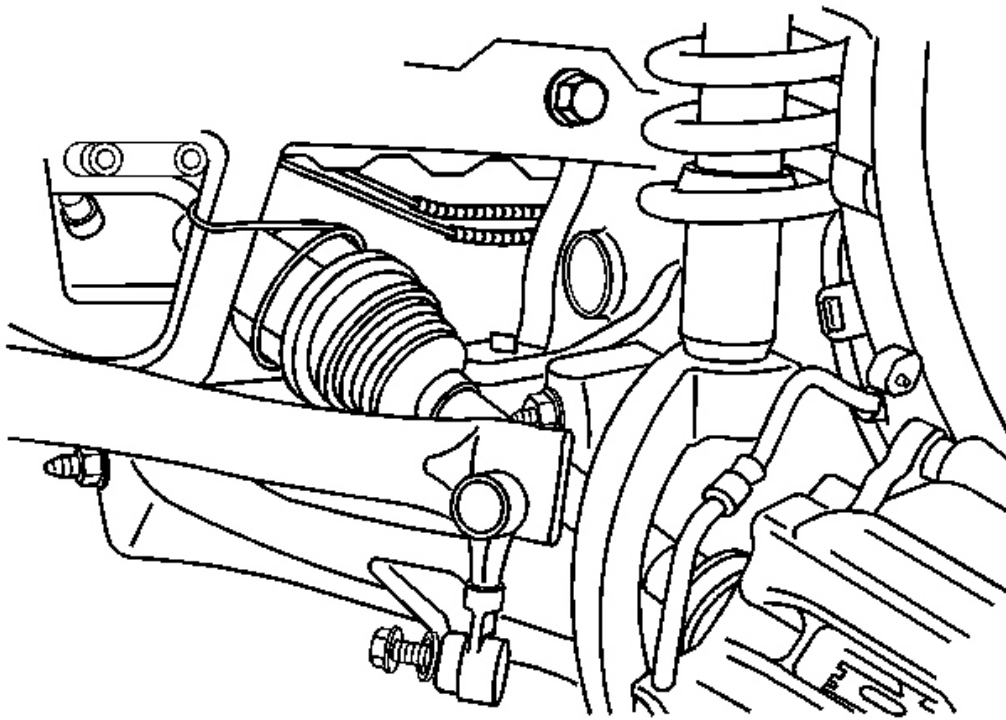
Fig. 19: Lower Control Arm View
Courtesy of GENERAL MOTORS CORP.

12. Install the stabilizer bar link. Refer to **Stabilizer Shaft Link Replacement** in Front Suspension.

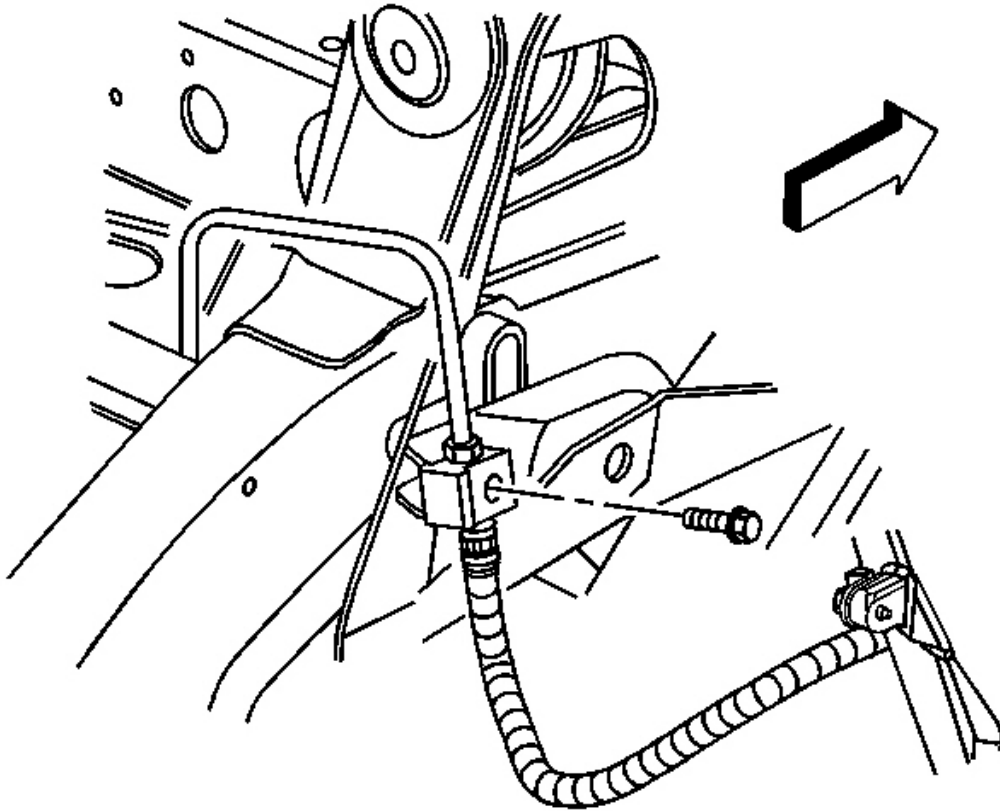
Fig. 20: Front Brake Hose Retaining Bolt
Courtesy of GENERAL MOTORS CORP.

13. Install the front brake hose retaining bolt. Refer to **Brake Hose Replacement - Front** in Hydraulic Brakes.

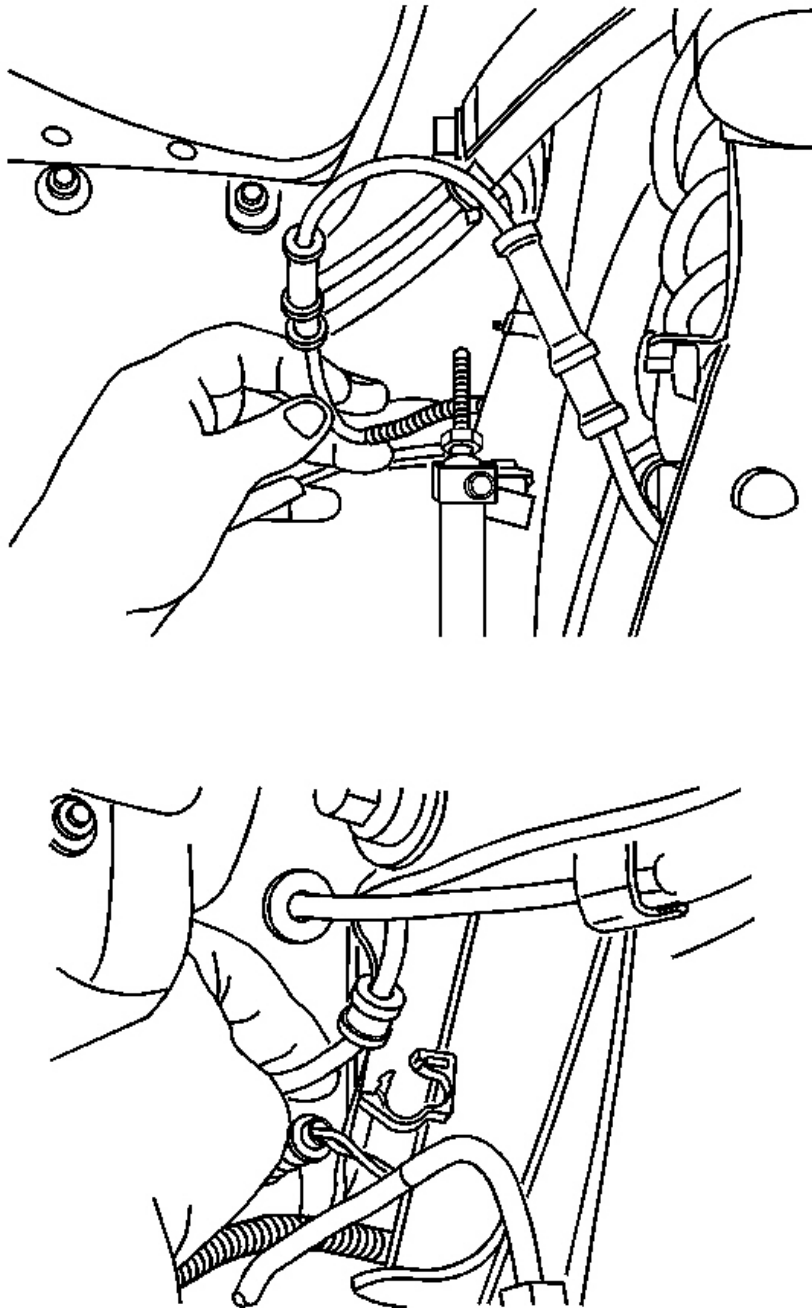
Fig. 21: Identifying Wheel Speed Sensor Wiring Harness
Courtesy of GENERAL MOTORS CORP.

14. Install the front wheel speed sensor wiring harness in the retainers.

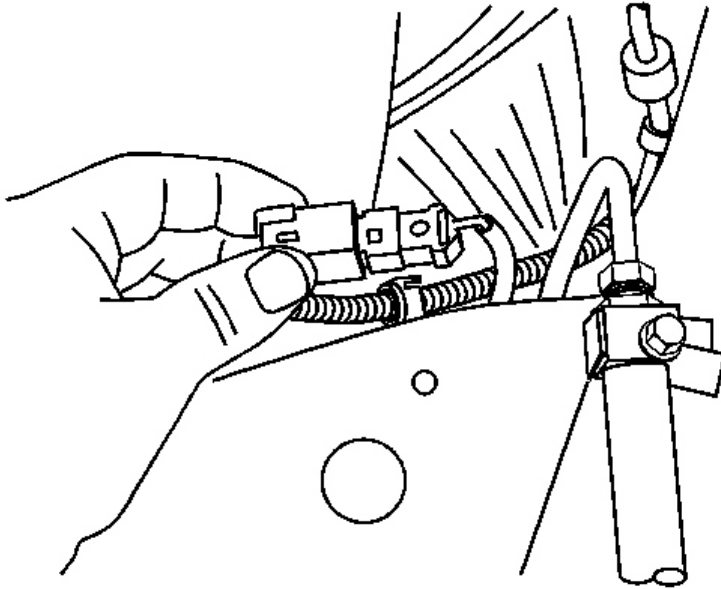
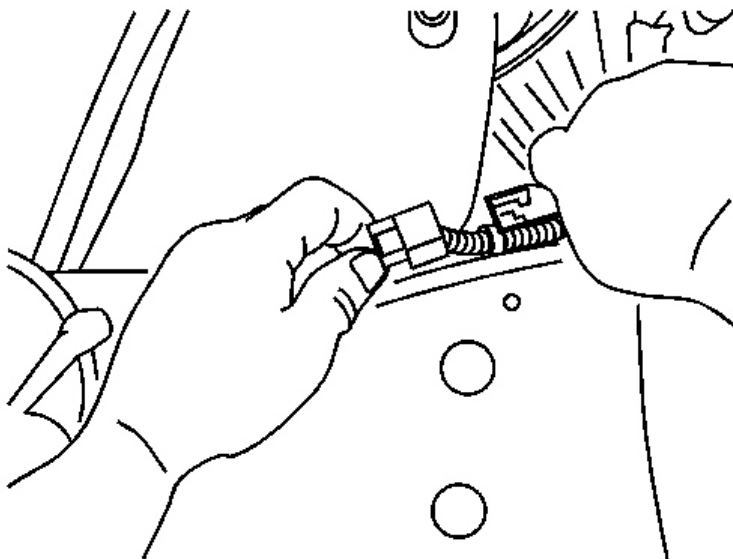
Fig. 22: Locating Connector

15. Reconnect the front wheel speed sensors electrical connector.

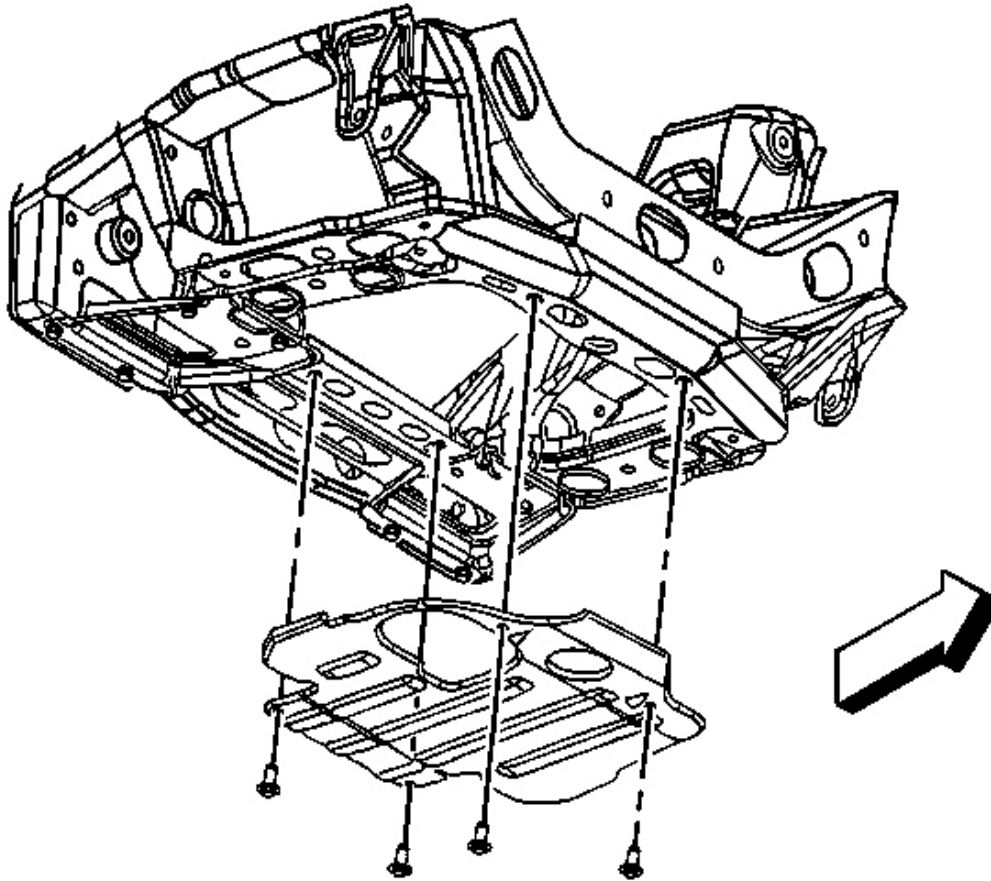
Fig. 23: Removing/Installing Engine Shield
Courtesy of GENERAL MOTORS CORP.

16. Install the engine protection shield. Refer to **Engine Protection Shield Replacement** in Frame and Underbody.

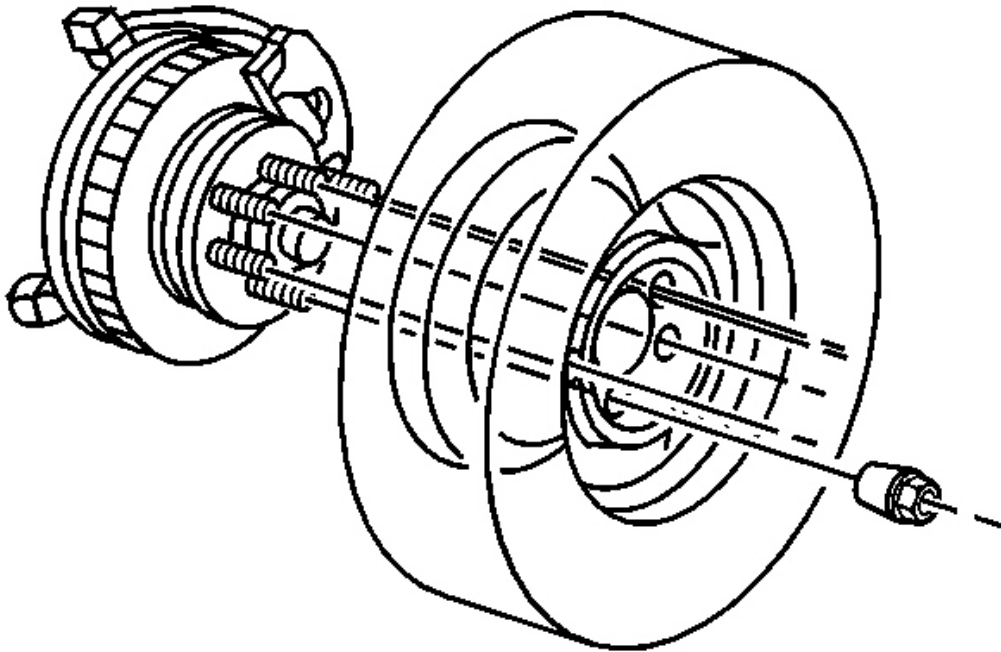
Fig. 24: View Of Tire/Wheel Assembly, Hub Assembly & Wheel Nuts
Courtesy of GENERAL MOTORS CORP.

17. Install the tire and wheel assembly. Refer to **Tire and Wheel Removal and Installation** in Tires and Wheels.
18. Lower the vehicle. Refer to **Lifting and Jacking the Vehicle** in General Information.
