2006 Buick Rainier
2006 Driveline/Axle Wheel Drive Shafts - Ascender, Envoy, Rainier & TrailBlazer

2006 Driveline/Axle

Wheel Drive Shafts - Ascender, Envoy, Rainier & TrailBlazer

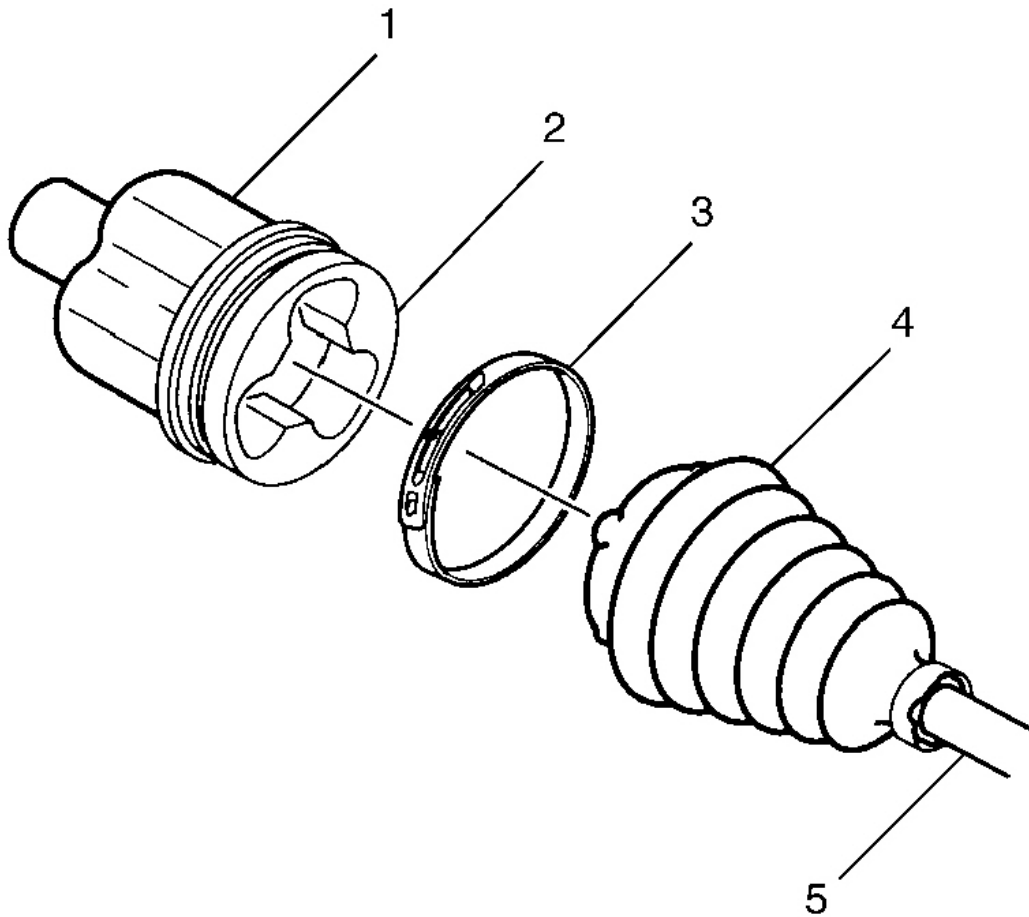
Fig. 25: View Of Tripot Boot
Courtesy of GENERAL MOTORS CORP.

1. Remove the clamp from the boot with a pair of side cutters.

IMPORTANT: Do not damage the tripot housing (1).

2. Use a hand grinder to cut through the swage ring.
3. Remove the tripot housing (1) and the trilobal tripot bushing (2) from the halfshaft bar (5).
4. Thoroughly degrease the housing (1) and the spider assembly.
5. Discard the tripot bushing.
6. Use 320 grit 3M cloth, or equivalent, to remove any evident corrosion in the transmission

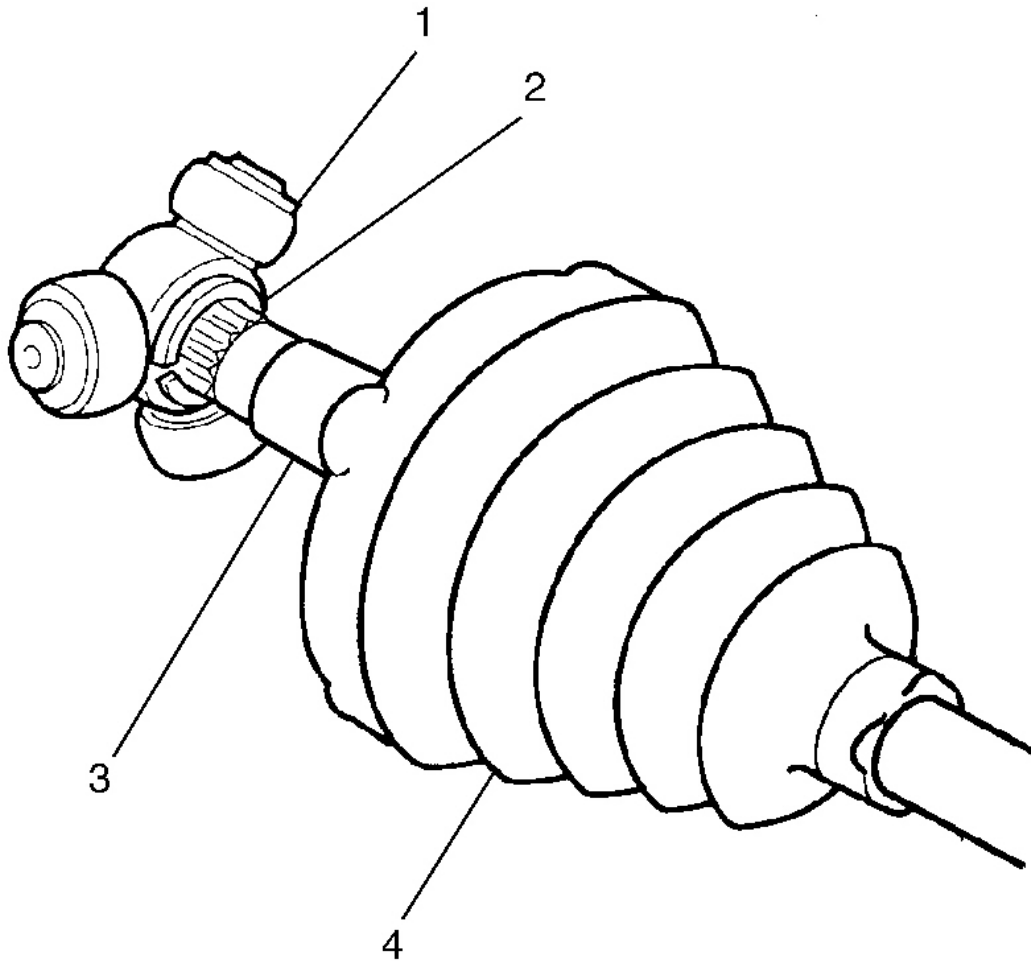
Fig. 26: Tripot Spider Assembly, Halfshaft Bar And Tripot Boot
Courtesy of GENERAL MOTORS CORP.

IMPORTANT: Handle the tripot spider assembly (1) with care. Tripot balls and needle rollers may separate from the spider trunnion if the tripot balls and needle rollers are not handled carefully.

8. Compress the tripot boot (4) onto the halfshaft bar (3), away from the spider assembly (1).

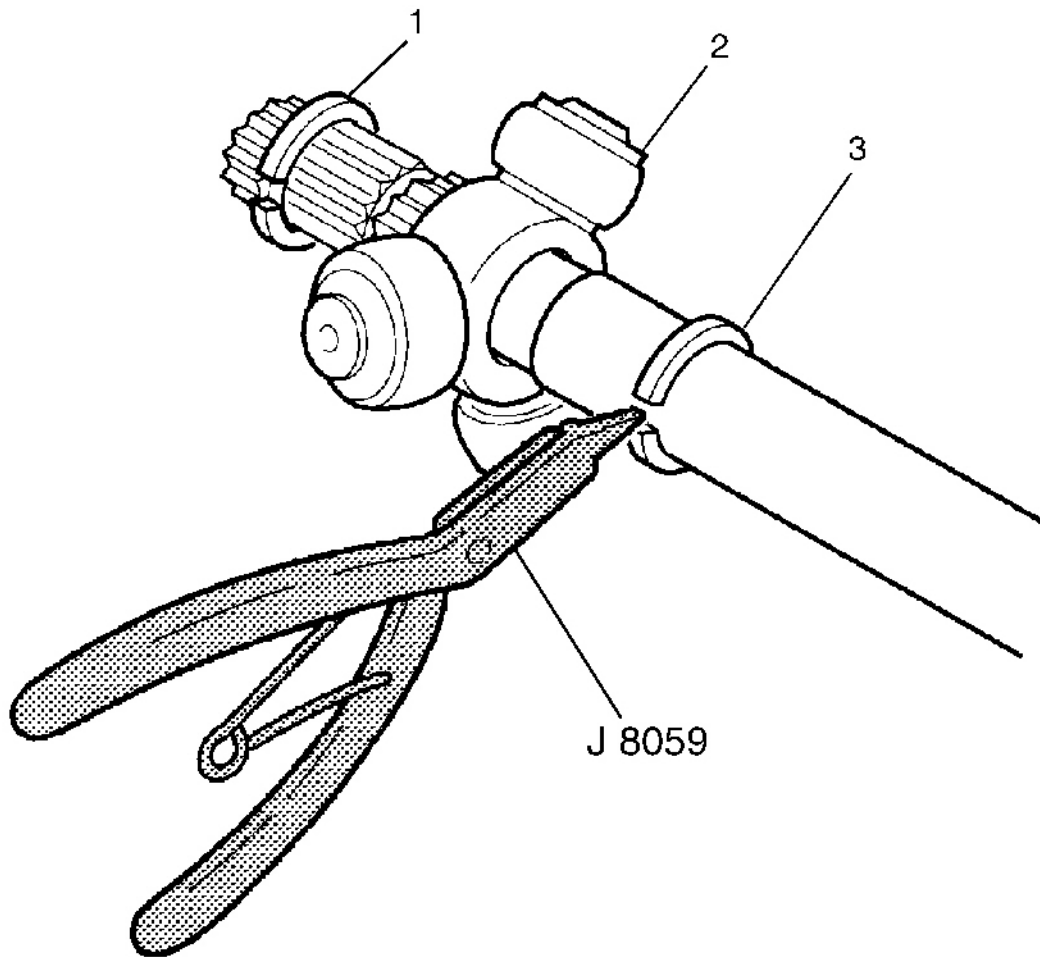
Fig. 27: Spacer Rings And Snap Ring Pliers
Courtesy of GENERAL MOTORS CORP.

9. Spread the spacer rings (1, 3) using **J 8059** , or equivalent, to remove the spider assembly (2). See **Special Tools**.

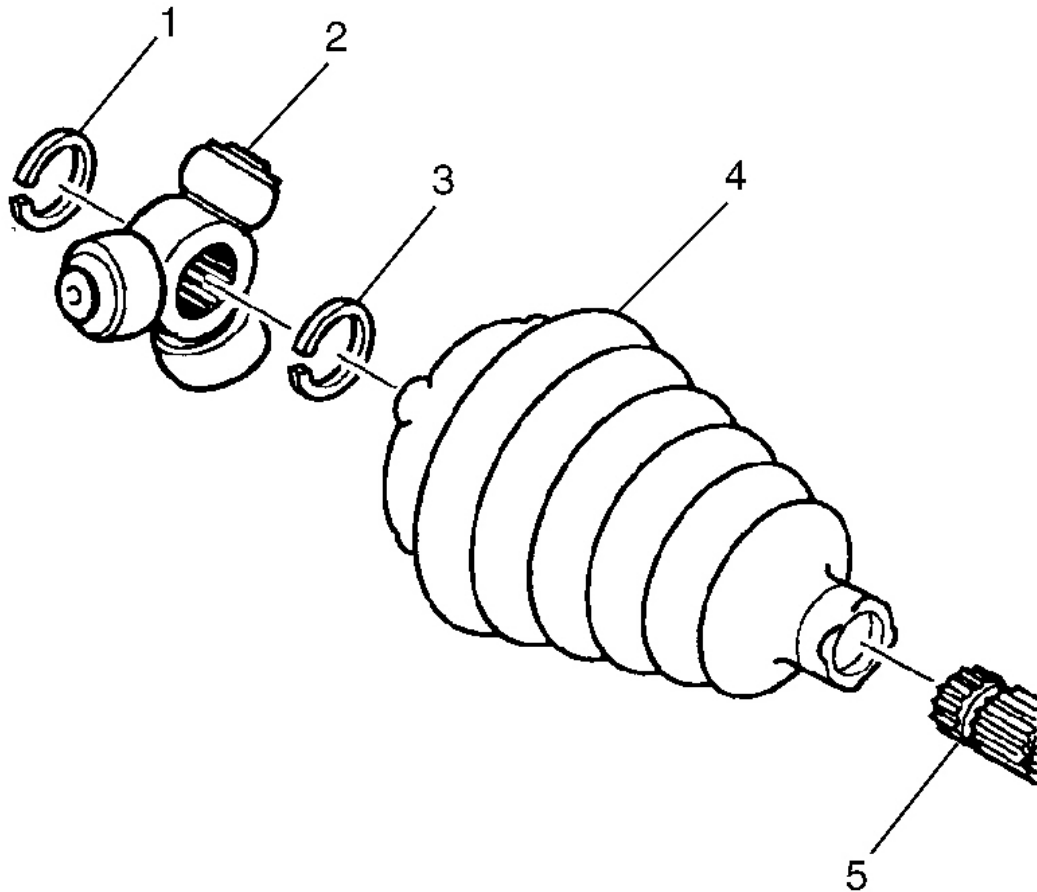
Fig. 28: View Of Spider Assembly, Rings & Tripot Boot
Courtesy of GENERAL MOTORS CORP.

10. Remove the following items:
 - The spacer ring (1)
 - The spider assembly (2)
 - The second spacer ring (3)
 - The tripot boot (4)
11. Discard the tripot boot and spacer rings.
12. Clean the halfshaft bar. Use a wire brush to remove any rust in the boot mounting area grooves.
13. Inspect the following items:

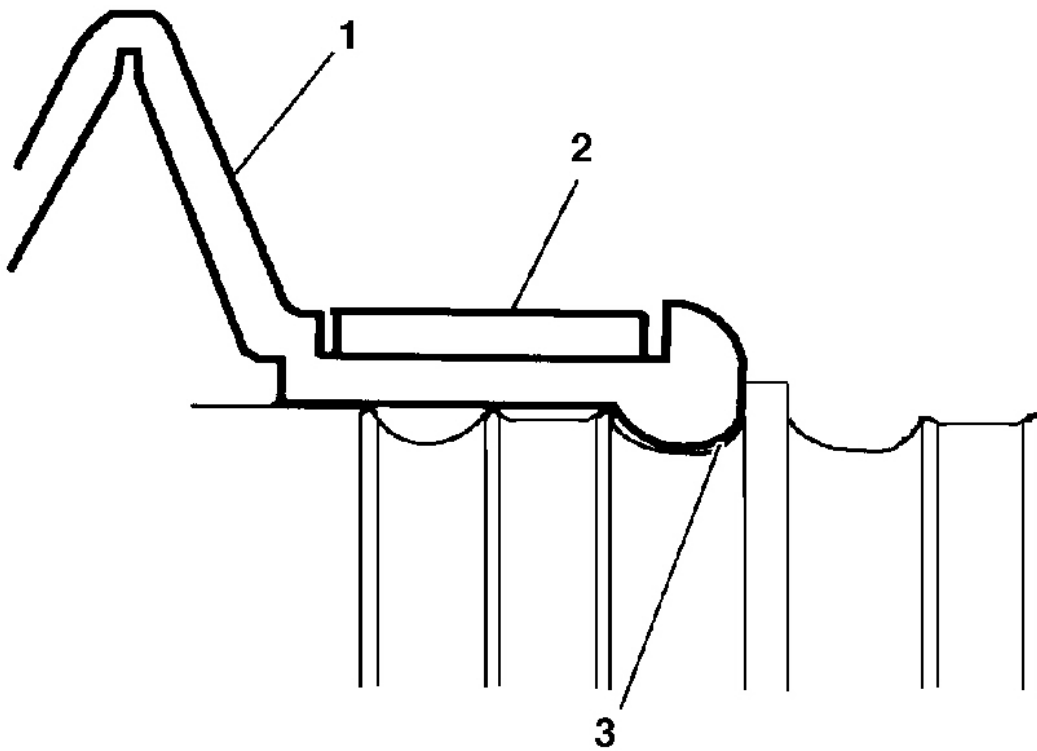
Fig. 29: Positionng Small End Of Joint Seal Into Joint Seal Groove
Courtesy of GENERAL MOTORS CORP.

1. Position the new swage clamp onto the neck of the boot. Do not swage.
2. Slide the new small swage clamp (2) and the boot (1) to the proper position on the halfshaft bar (3).

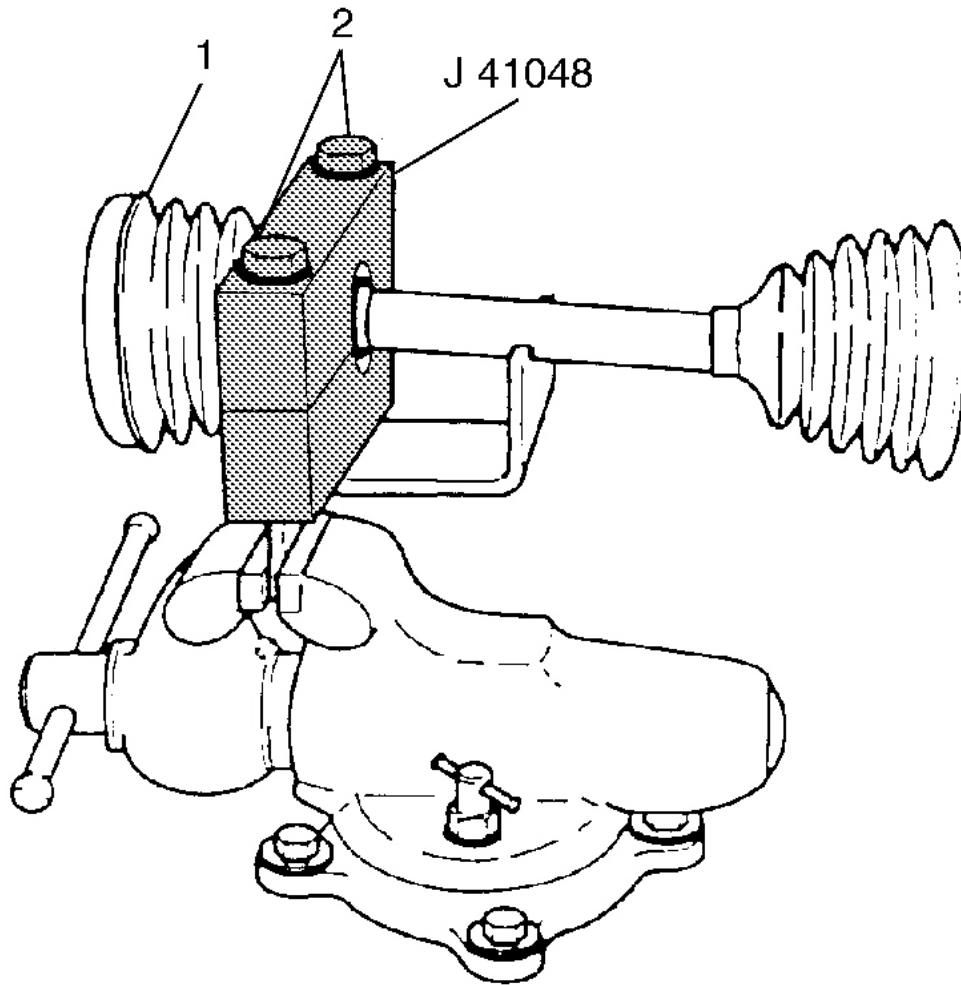
Fig. 30: Swaging Retaining Clamp Ring
Courtesy of GENERAL MOTORS CORP.

3. Position the neck of the boot in the boot groove on the halfshaft bar.
4. In order to swage the swage clamp, position the inboard end (1) of the halfshaft assembly in **J 41048** . See **Special Tools**.

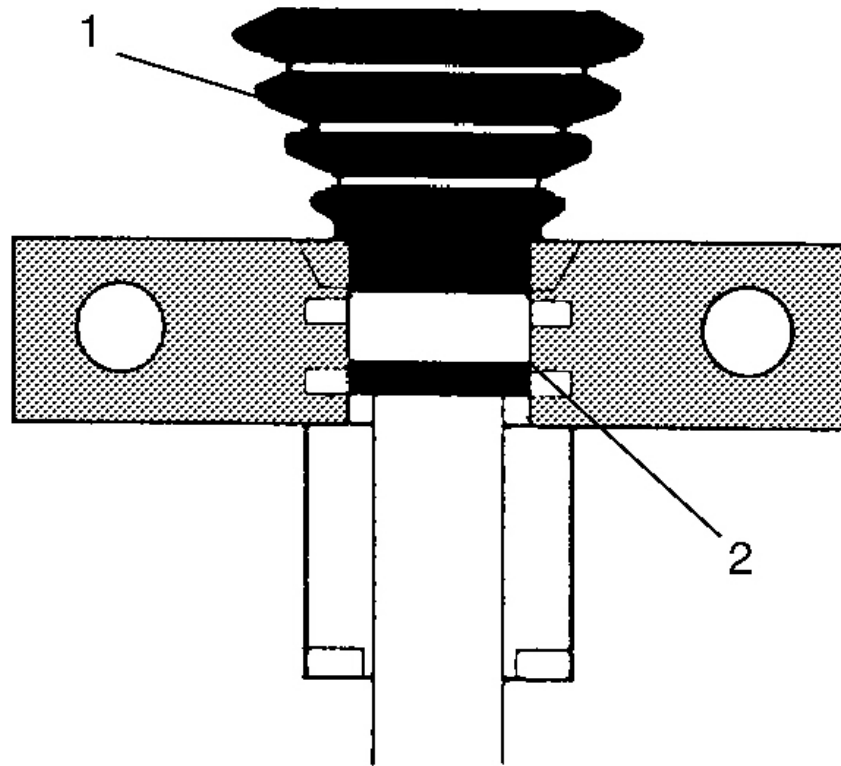
Fig. 31: Identifying Halfshaft Inboard Seal & Swage Ring
Courtesy of GENERAL MOTORS CORP.

5. Align the swage clamp (2) within **J 41048** . See **Special Tools**.

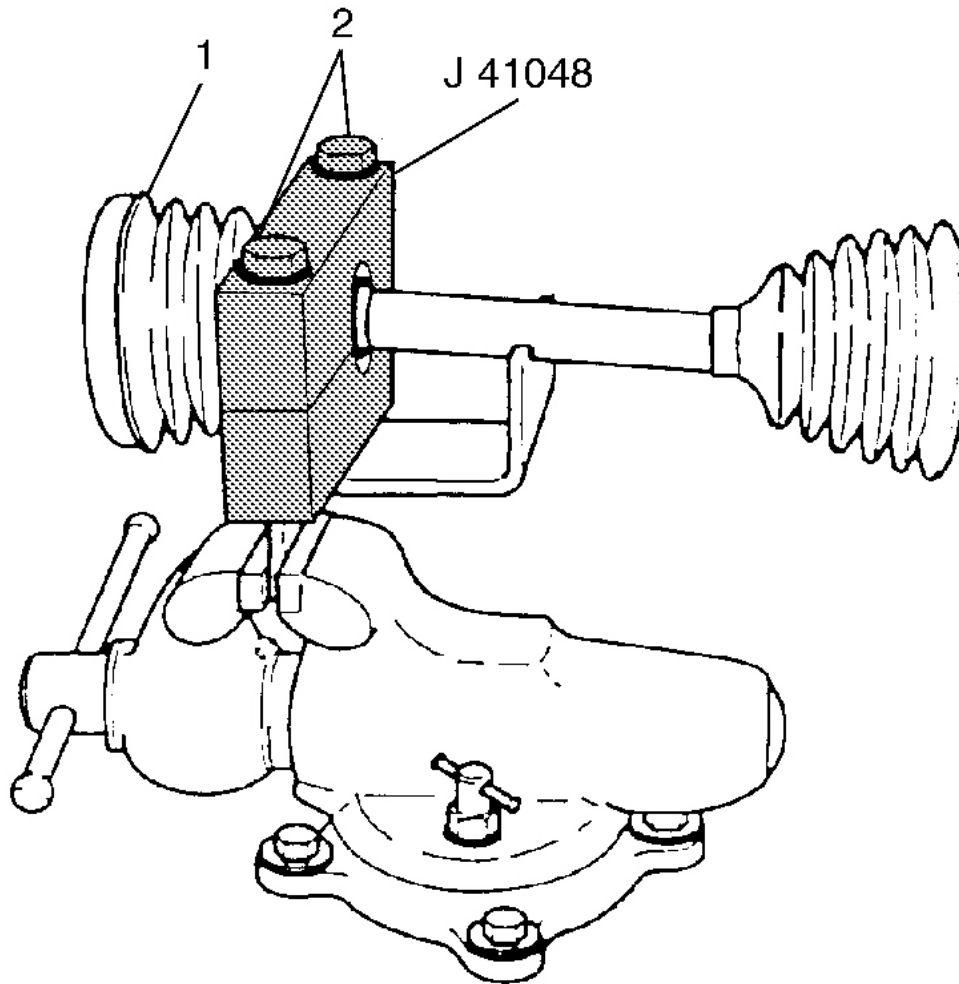
Fig. 32: Swaging Retaining Clamp Ring
Courtesy of GENERAL MOTORS CORP.

6. Place the top half of the **J 41048** on the bottom half. See **Special Tools**.
7. Inspect to make sure there are no pinch points on the boot before proceeding.
8. Insert the bolts (2).
9. Tighten the bolts (2) by hand until snug.

Tighten: Each bolt 180 degrees at a time, using a ratchet wrench. Alternate between each bolt until both sides are bottomed.

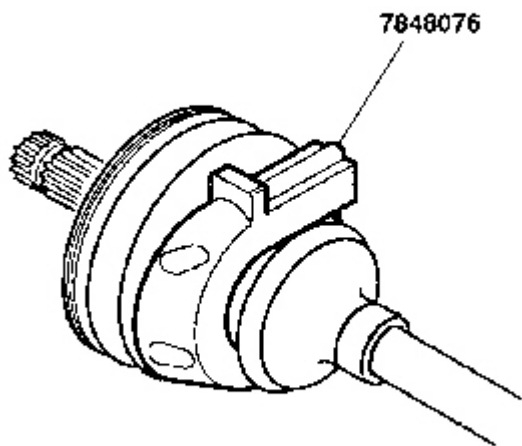
Fig. 33: Convolute Retainer Over Boot
Courtesy of GENERAL MOTORS CORP.

IMPORTANT: Assemble the joint with the convolute retainer in the correct

position. Assemble the joint to meet the specified dimension to avoid boot damage.

14. Install the convolute retainer over the boot capturing four convolutions.

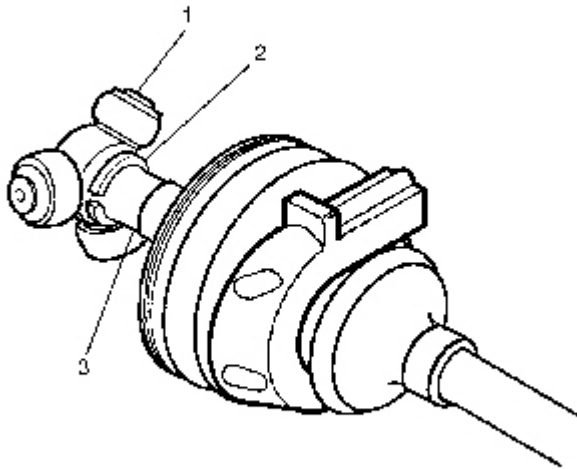
Fig. 34: Spider Assembly, Spacer Ring And Halfshaft Bar
Courtesy of GENERAL MOTORS CORP.

15. Install the spacer ring (2) and spider assembly (1) onto the halfshaft bar (3).
16. Install the other spacer ring in the groove at the end of the halfshaft bar. Ensure that the rings are fully seated.

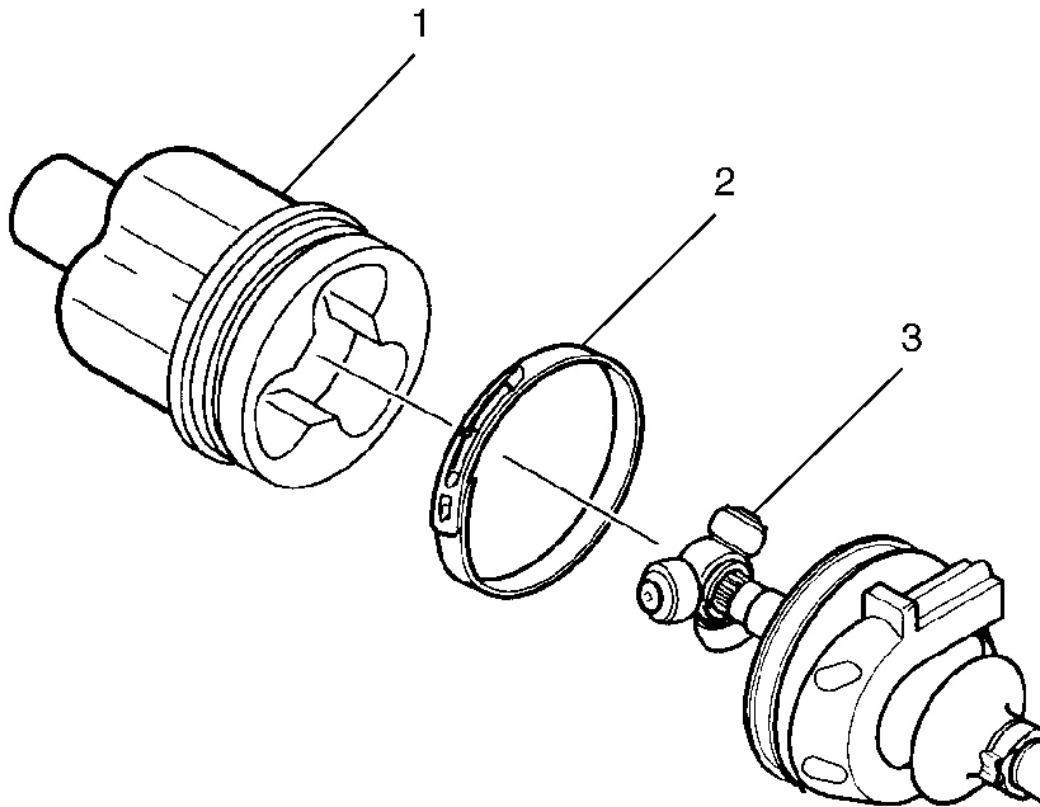
Fig. 35: Expanded View Of Tripot Housing
Courtesy of GENERAL MOTORS CORP.

17. Pack the boot and housing with the grease supplied in the kit. The amount of grease supplied in this kit has been pre-measured for this application.
18. Place the large retaining clamp (2) on the boot.
19. Place the housing (1) and the new trilobal tripot bushing over the spider assembly (3).
20. Install the boot onto the trilobal tripot bushing.

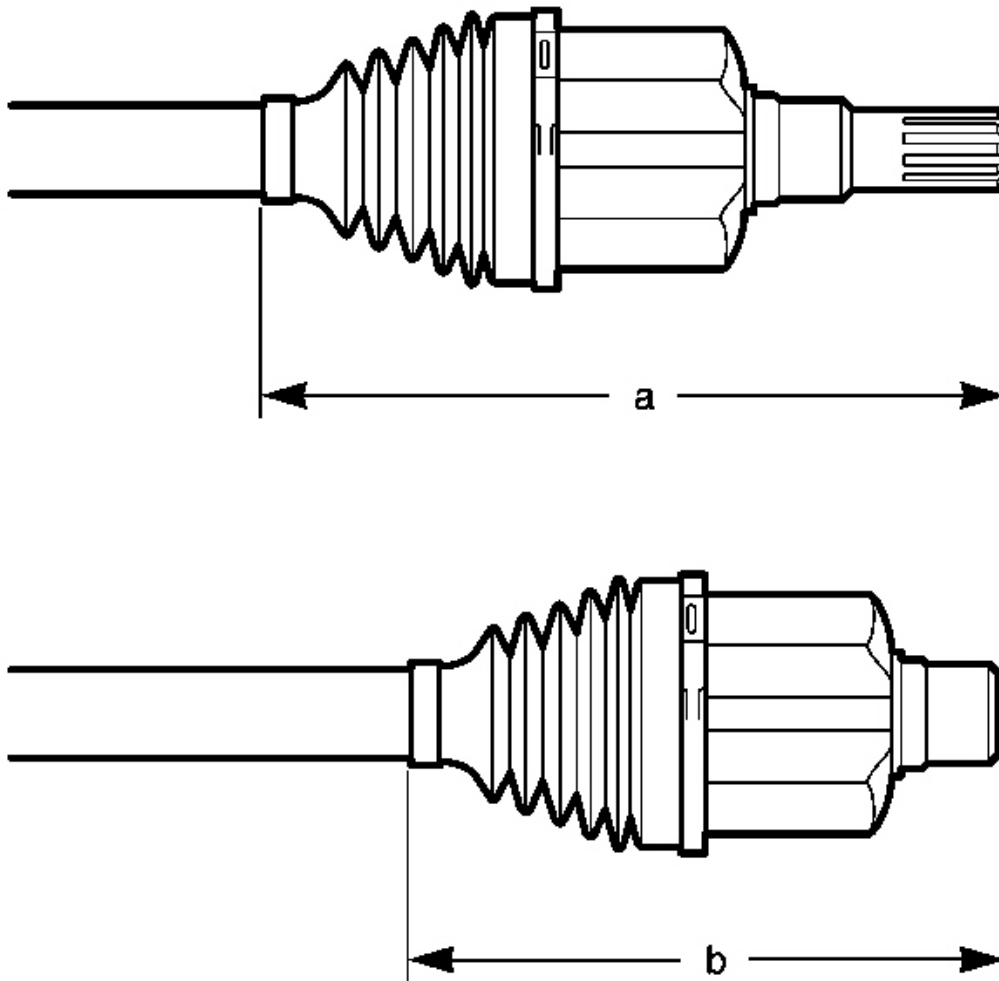
Fig. 36: Inspecting Inboard Stroke Position
Courtesy of GENERAL MOTORS CORP.

21. Inspect the inboard stroke position (see diagram).
- For male tripot housing assembly: dimension a = 280 mm (11 in).
 - For female tripot housing assembly: dimension b = 228 mm (9 in).

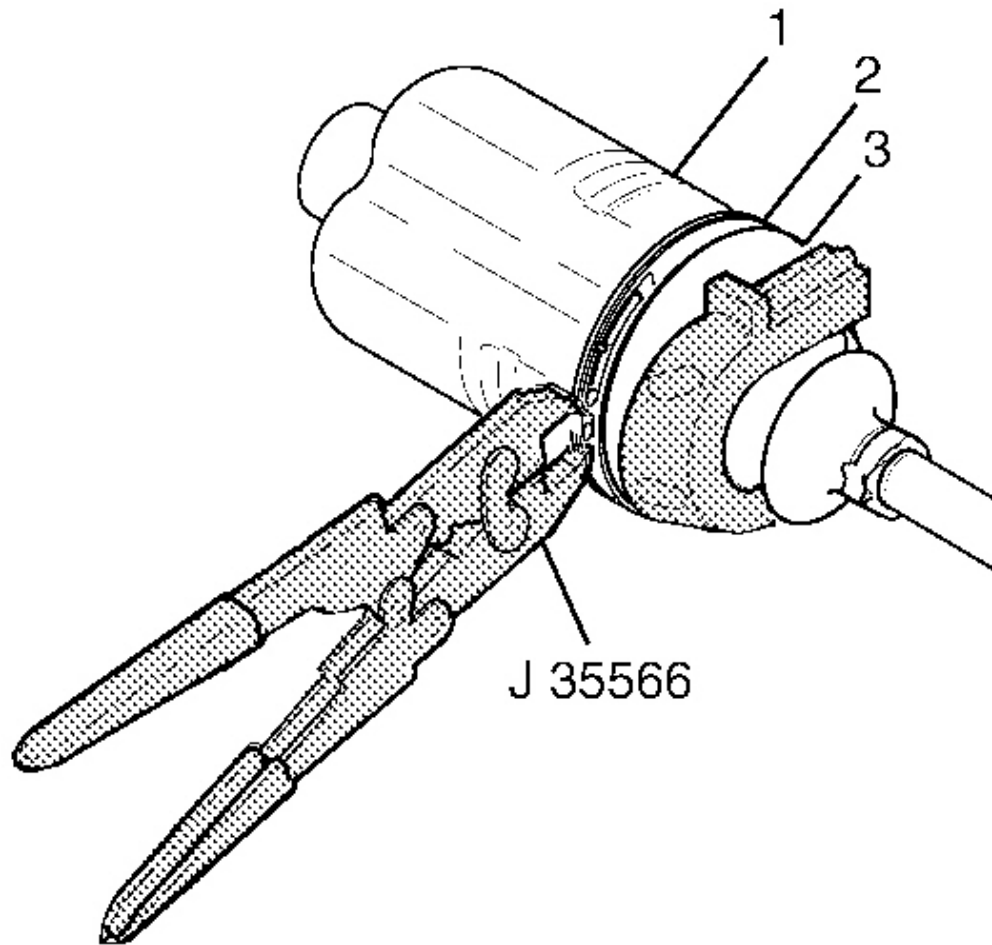
Fig. 37: Identifying J 35566
Courtesy of GENERAL MOTORS CORP.

22. Secure the large retaining clamp (2) and the boot (3) to the housing (1) using **J 35566** .

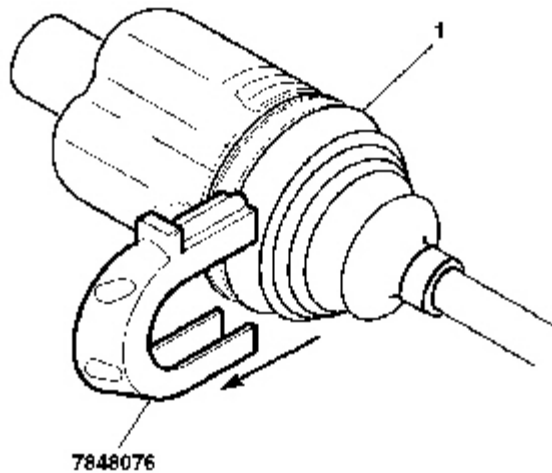
Fig. 38: Boot And 7848076
Courtesy of GENERAL MOTORS CORP.

23. Remove the convolute retainer from the boot (1).

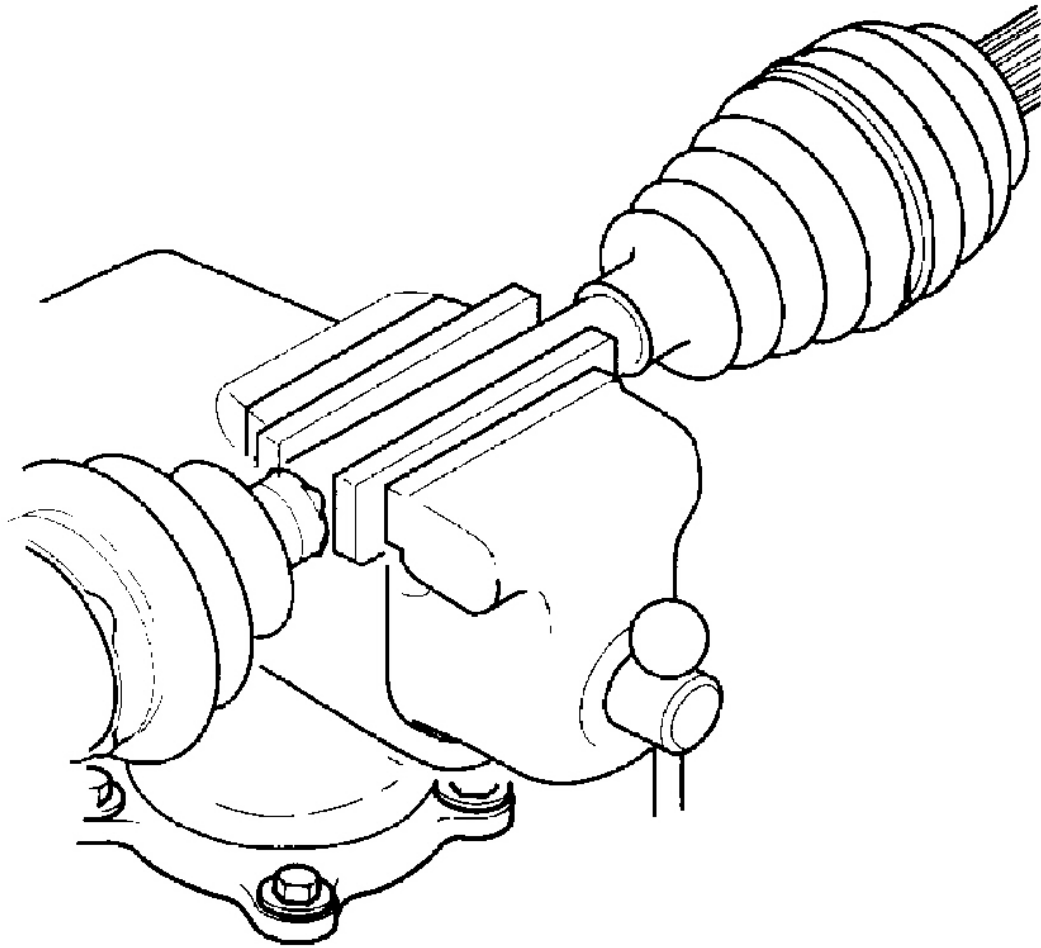
Fig. 39: Securing Halfshaft
Courtesy of GENERAL MOTORS CORP.

1. Place the halfshaft in a vise.
2. Place protective covers over the vise jaws.

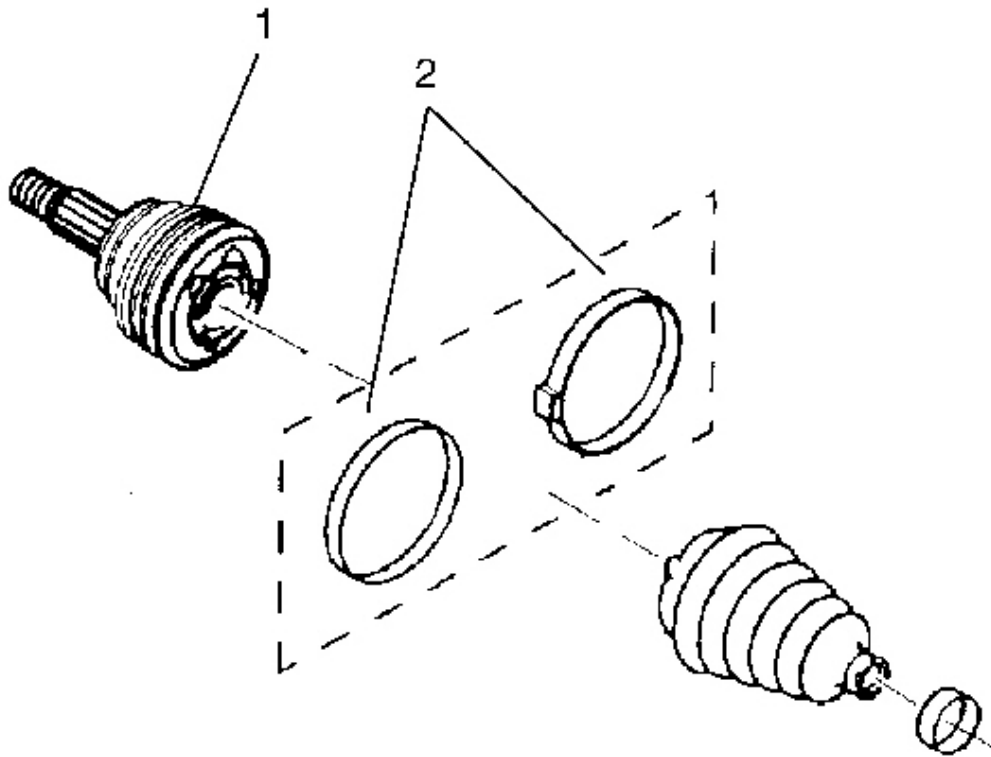
Fig. 40: CV Joint Outer Race And Swage Rings
Courtesy of GENERAL MOTORS CORP.

3. Use a hand grinder to cut through the swage rings (2). Do not damage the outer race.
4. Compress the seal on the halfshaft and away from the CV joint outer race (1).
5. Wipe all grease away from the face of the CV joint.

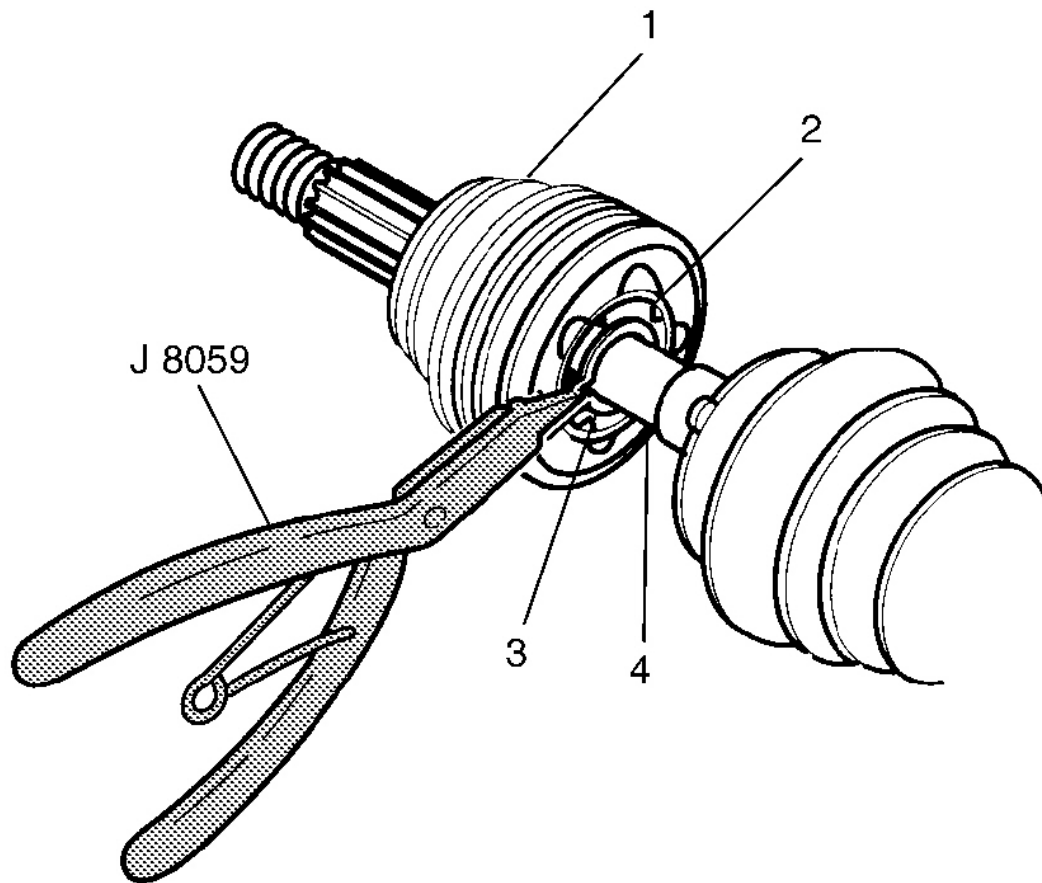
Fig. 41: Identifying J 8059

6. Find the halfshaft retaining snap ring (3), which is located in the inner race (2).
7. Spread the snap ring ears apart using **J 8059** (or equivalent). See **Special Tools**.
8. Pull the CV joint from the halfshaft (4).
9. Discard the old seal.

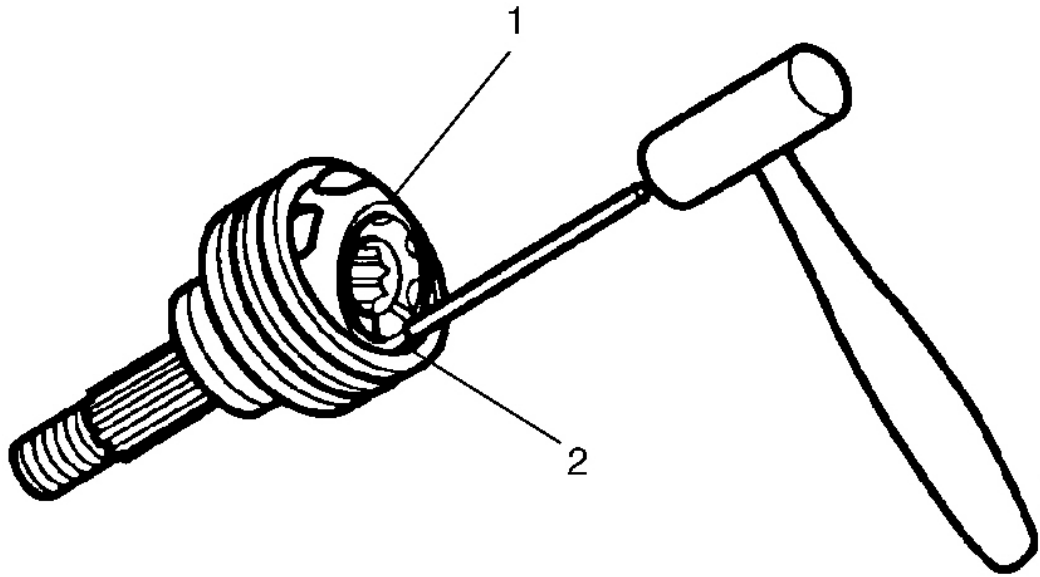
Fig. 42: Taping Gently On Brass Drift With A Hammer In Order To Tilt Cage
Courtesy of GENERAL MOTORS CORP.

10. Place a brass drift against the cage (1).
11. Tap gently on the brass drift in order to tilt the cage.
12. Remove the first ball (2) when the cage tilts.
13. Repeat the previous step to remove all of the balls.

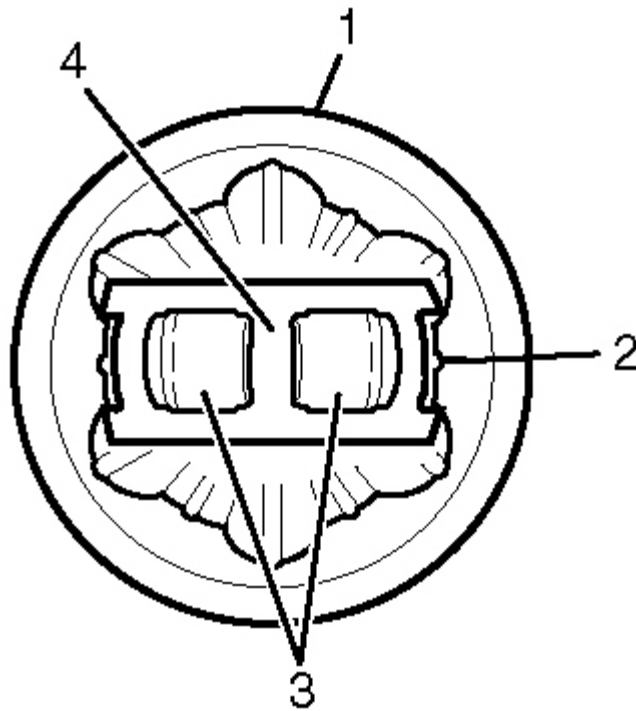
Fig. 43: View Of Outer Race, Inner Race, Cage Window & CV Joint Cage
Courtesy of GENERAL MOTORS CORP.

14. Pivot the cage (4) and the inner race 90 degrees to the centerline of the outer race (1). At the same time, align the cage windows (3) with the lands of the outer race (2).
15. Lift out the cage (4) and the inner race.

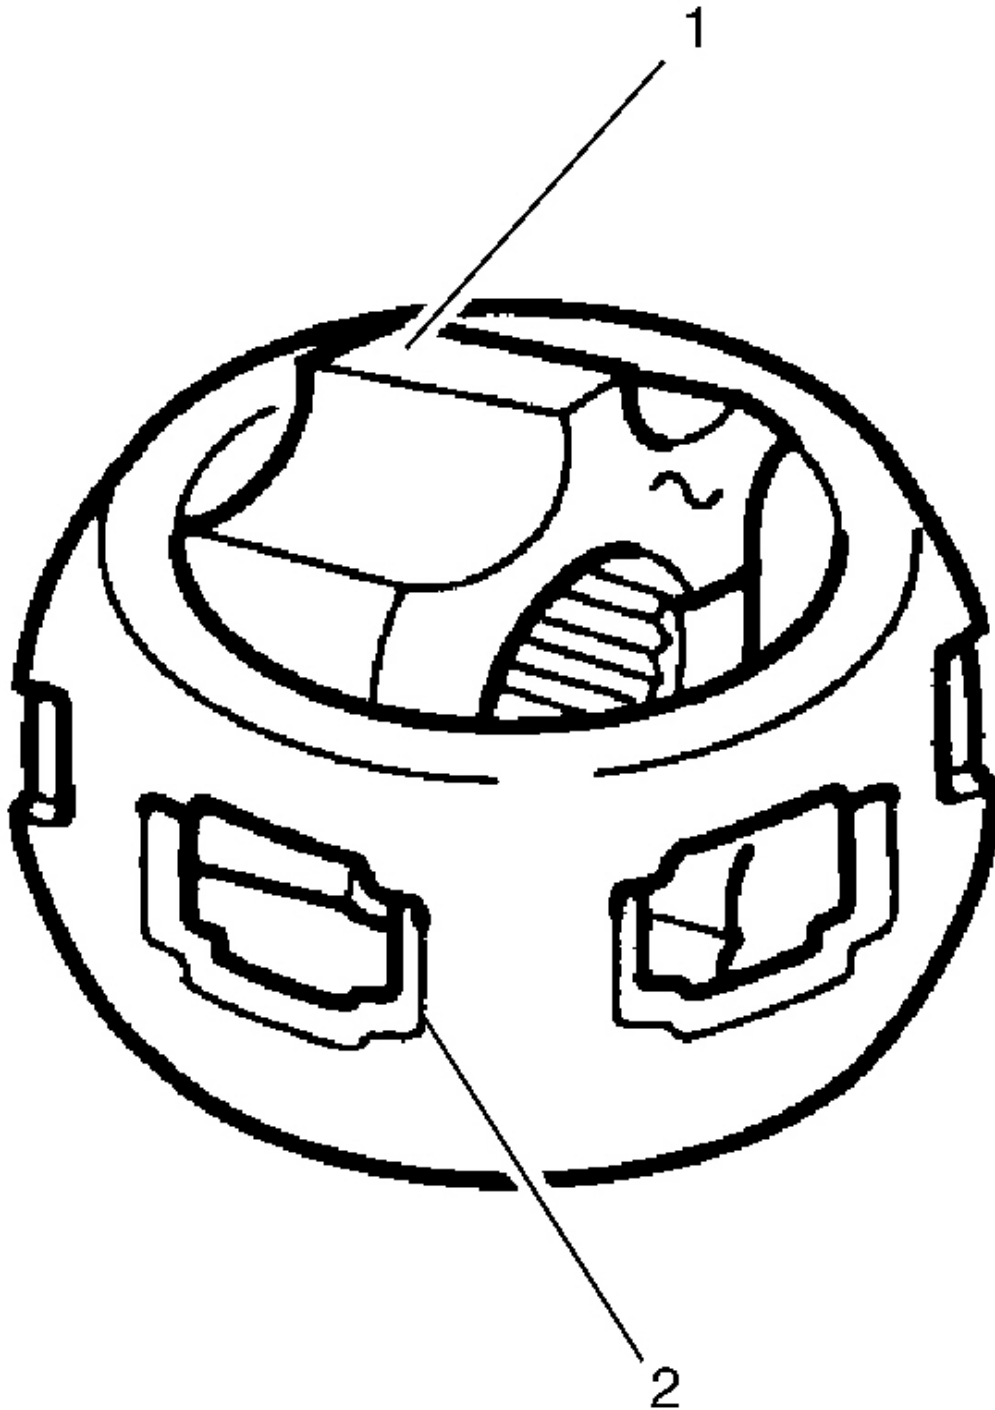
Fig. 44: View Of Inner Race & Cage
Courtesy of GENERAL MOTORS CORP.

16. Remove the inner race (1) from the cage (2) by rotating the inner race (1) upward.
17. Thoroughly degrease all of the CV joint parts.
18. Check the outer CV joint assembly for unusual wear, cracks, or other damage. Replace any damaged parts.
19. Clean the halfshaft bar. Use a wire brush to remove any rust in the seal mounting area (grooves).

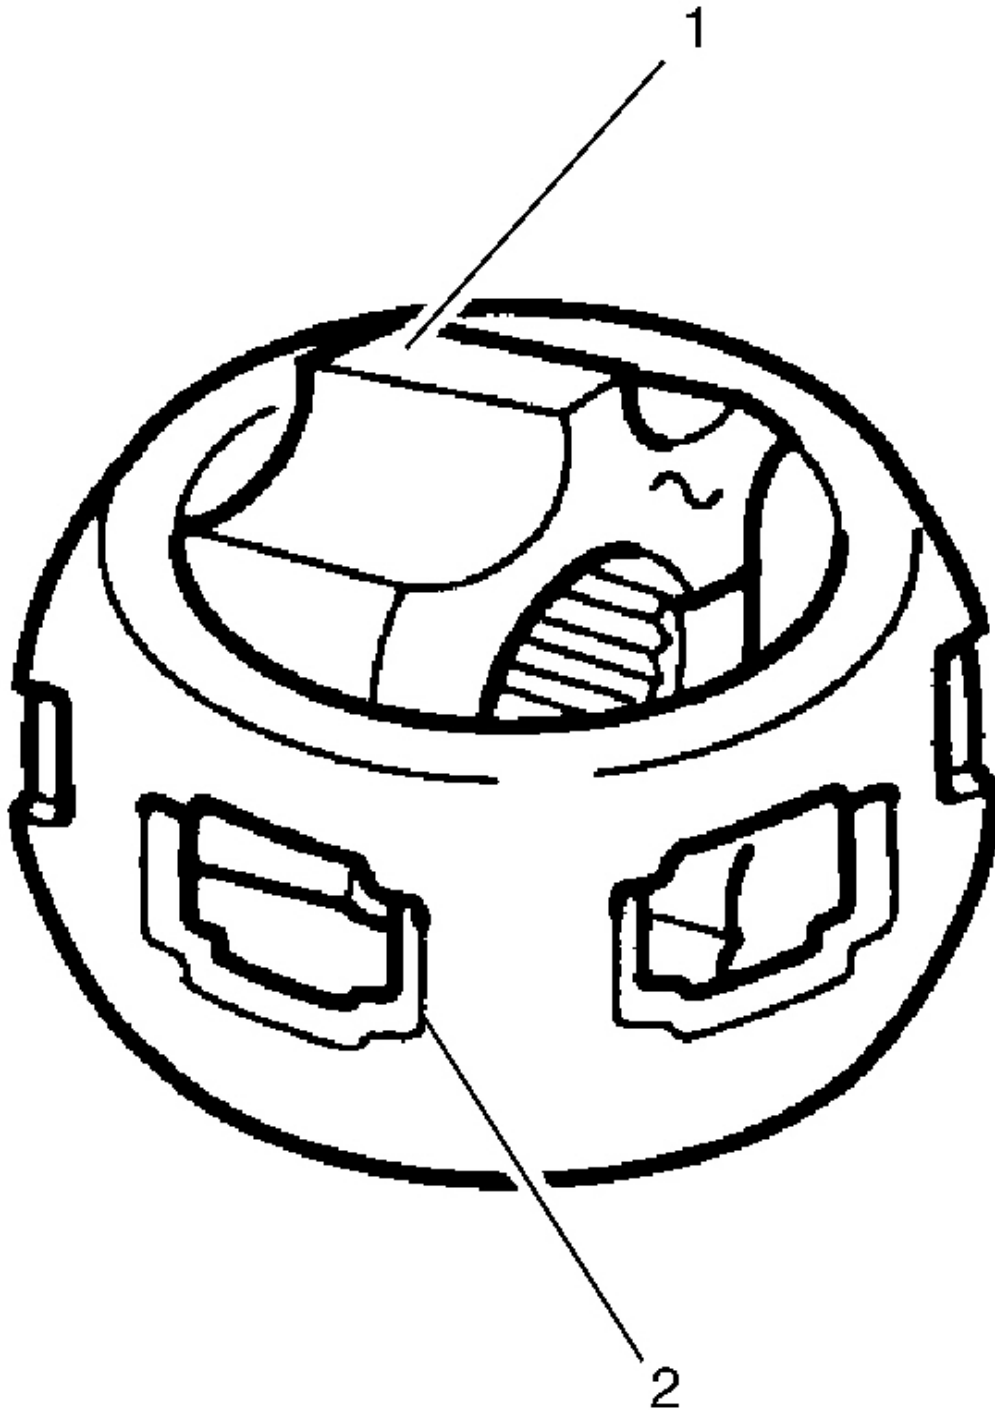
Fig. 45: View Of Inner Race & Cage
Courtesy of GENERAL MOTORS CORP.

1. Inspect all of the parts for unusual wear, cracks, or other damage.
2. Put a light coat of the recommended grease on the inner and the outer race grooves.
3. Insert the inner race (1) into the cage (2) by rotating the inner race downward.
4. Hold the inner race (1) at 90 degrees to the centerline of the cage.

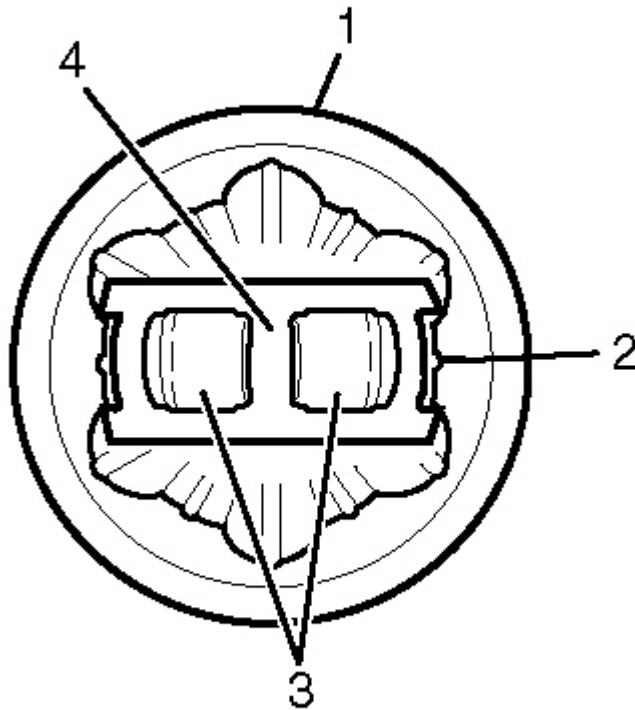
Fig. 46: View Of Outer Race, Inner Race, Cage Window & CV Joint Cage
Courtesy of GENERAL MOTORS CORP.

5. Align the lands of the inner race (2) with the windows of the cage (3).
6. Rotate the inner race downward to insert the inner race into the cage.

7. Insert the cage (4) and inner race into the outer race (1).

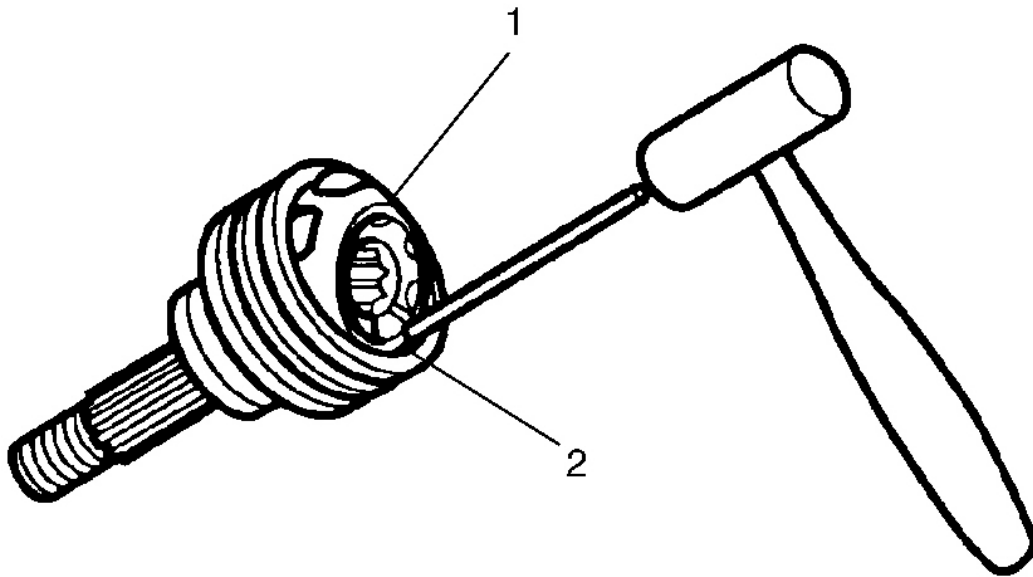
Fig. 47: Taping Gently On Brass Drift With A Hammer In Order To Tilt Cage
Courtesy of GENERAL MOTORS CORP.

8. Place a brass drift against the cage (1).
9. Tap gently on the brass drift in order to tilt the cage (1).
10. Install the first ball (2) when the cage tilts.
11. Repeat previous step to reinstall all of the balls.

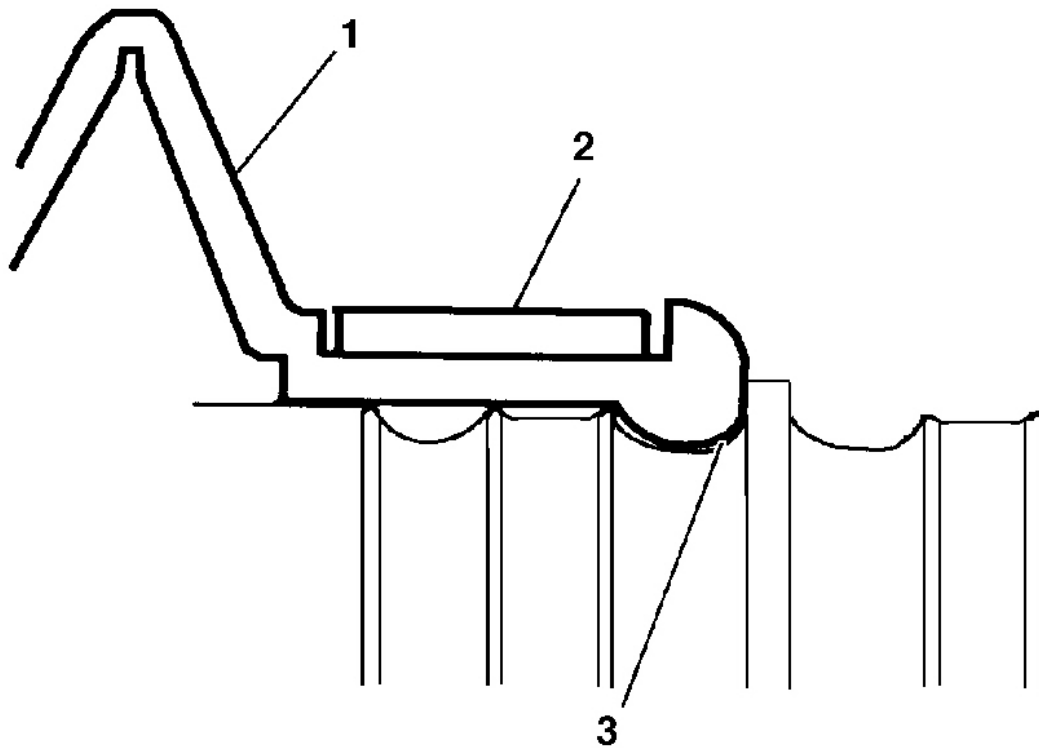
Fig. 48: Positionng Small End Of Joint Seal Into Joint Seal Groove
Courtesy of GENERAL MOTORS CORP.

12. Pack the CV joint seal and the CV joint assembly with the grease supplied in the kit. The amount of grease supplied in this kit has been pre-measured for this application.
13. Place the new small swage clamp (2) onto the CV joint seal (1).
14. Place the large retaining clamp on the seal (1).
15. Position the small end of the CV joint seal (1) into the joint seal groove (3) on the halfshaft bar.

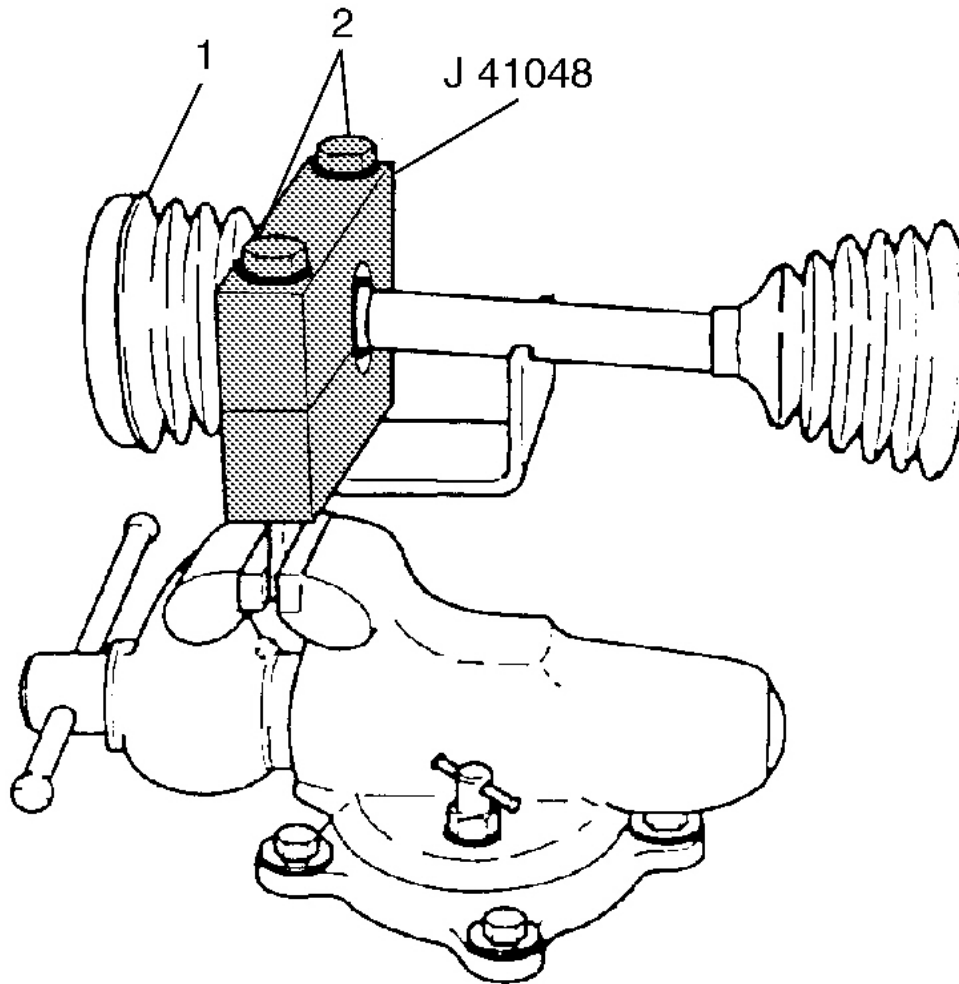
Fig. 49: Swaging Retaining Clamp Ring
Courtesy of GENERAL MOTORS CORP.

16. Position the outboard end of the halfshaft assembly (1) in **J 41048** . See **Special Tools**.

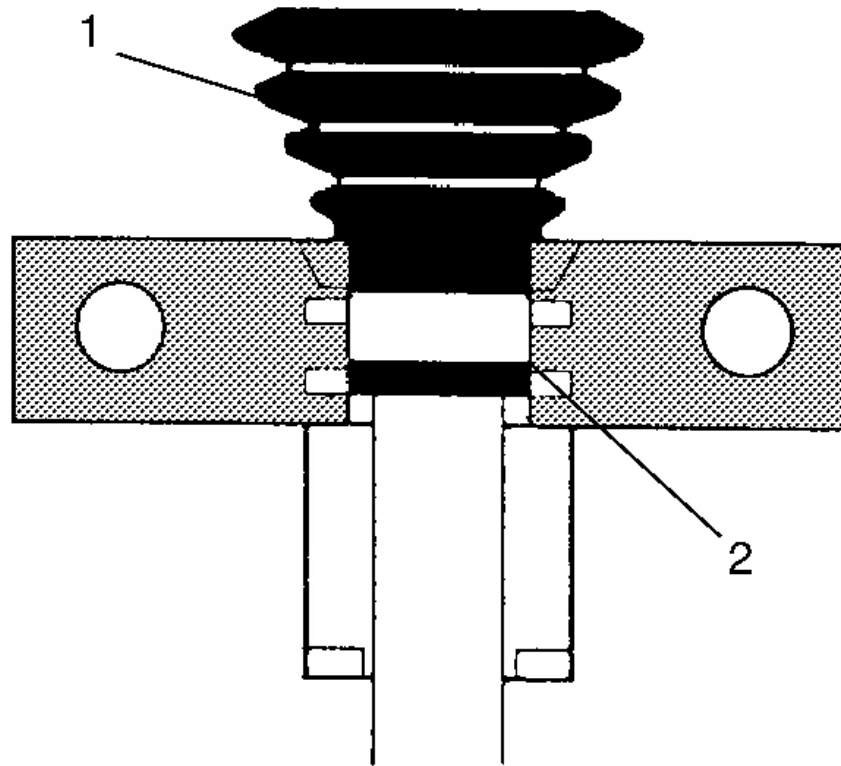
Fig. 50: Identifying Halfshaft Inboard Seal & Swage Ring
Courtesy of GENERAL MOTORS CORP.

17. Align the swage clamp (2) within **J 41048** . See **Special Tools**.
