2006 Buick Rainier
2006 Driveline/Axle Wheel Drive Shafts - Ascender, Envoy, Rainier & TrailBlazer

2006 Driveline/Axle

Wheel Drive Shafts - Ascender, Envoy, Rainier & TrailBlazer

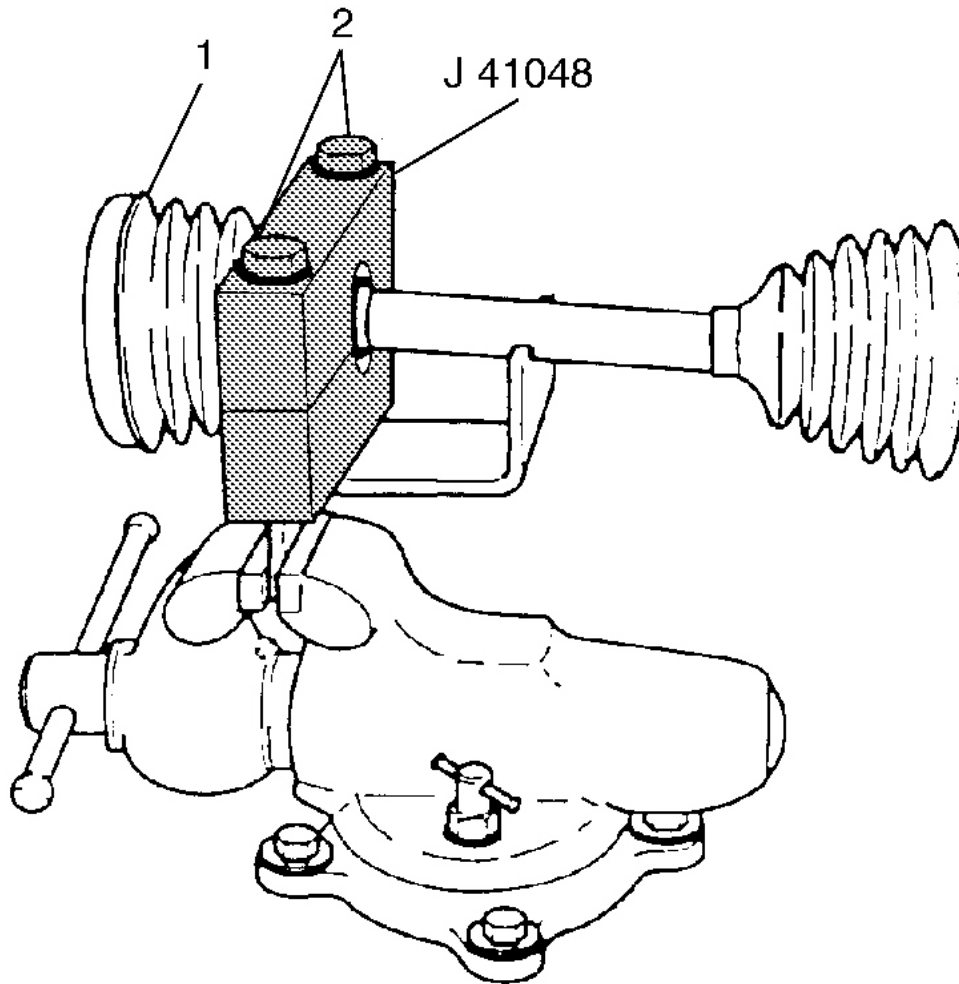
Fig. 51: Swaging Retaining Clamp Ring
Courtesy of GENERAL MOTORS CORP.

18. Place the top half of the **J 41048** on the bottom half. See **Special Tools**.
19. Check to make sure there are no pinch points on the seal before proceeding with procedures.
20. Insert the bolts (2). Tighten the bolts (2) by hand until snug.

Tighten: Tighten each bolt 180 degrees at a time, using a ratchet wrench. Alternate between each bolt until both sides are bottomed.

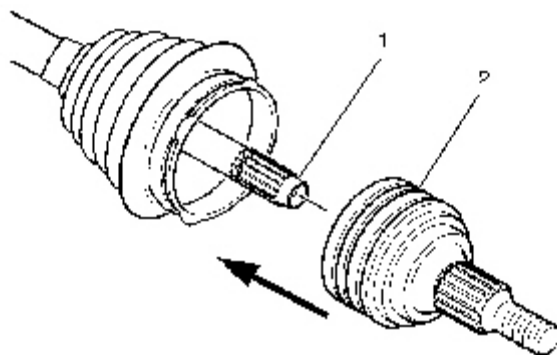
Fig. 52: Halfshaft Bar And CV Joint
Courtesy of GENERAL MOTORS CORP.

IMPORTANT: Ensure that the retaining ring side of the CV joint inner race faces the halfshaft bar (1) before installation.

IMPORTANT: The retaining snap ring inside of the inner race engages in the halfshaft bar groove with a click when the CV joint is in the proper position.

26. Slide the CV joint (2) onto the halfshaft bar (1).
27. Pull on the CV joint (2) to verify engagement.

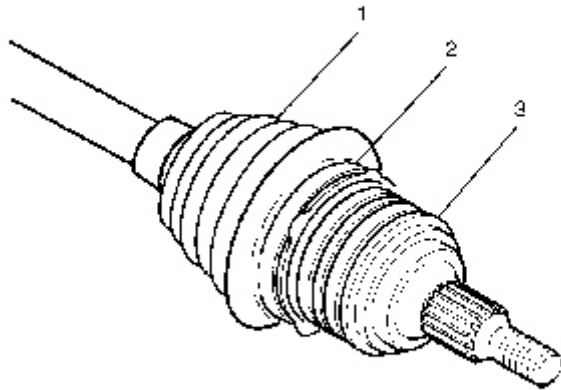
Fig. 53: CV Joint Seal, Retaining Ring And CV Joint Outer Race
Courtesy of GENERAL MOTORS CORP.

28. Slide the large diameter of the CV joint seal (1), with the large retaining ring (2) in place, over the outside edge of the CV joint outer race (3).
29. Position the lip of the CV joint seal (1) into the groove on the CV joint outer race (3).
30. Manipulate the CV joint seal (1) to remove any excess air.

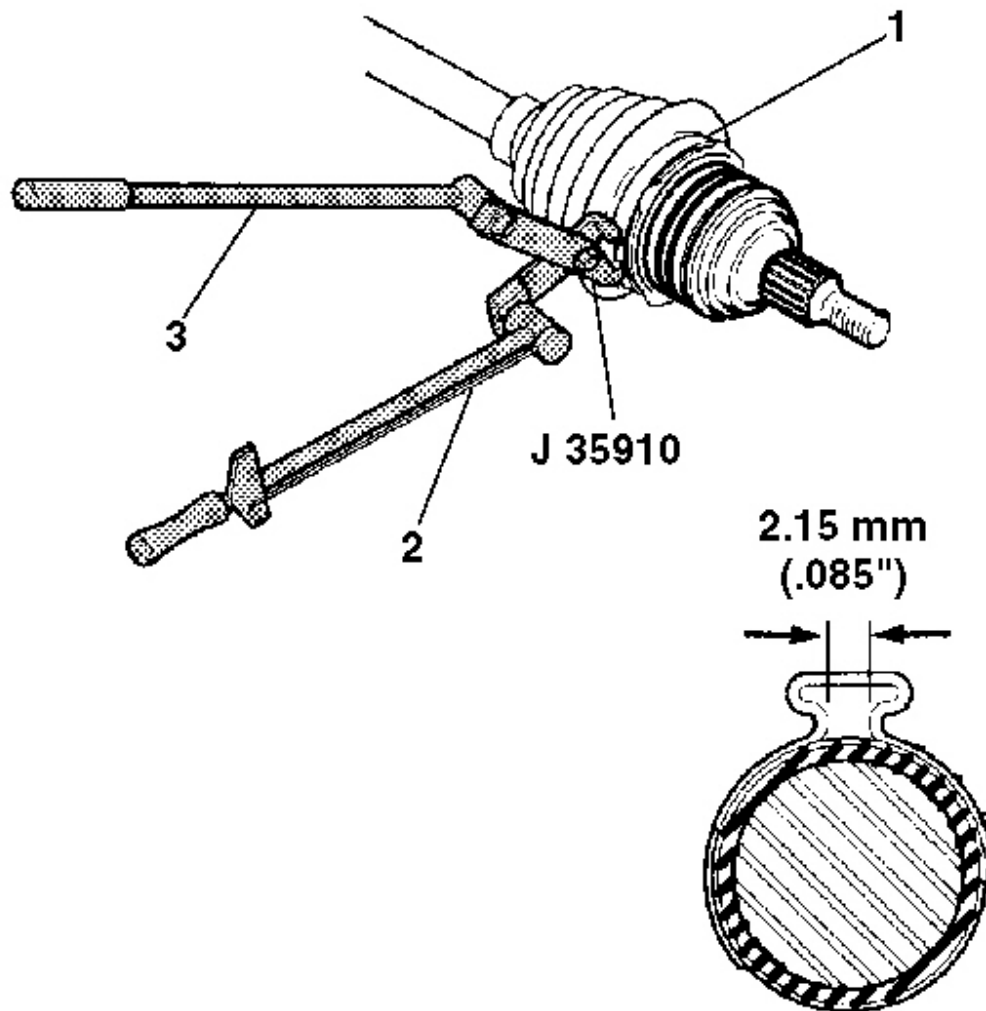
Fig. 54: Large Retaining Clamp, Breaker Bar, Torque Wrench And Seal Clamp Tool

31. Secure the large retaining clamp (1) to the housing with **J 35910** (or equivalent), a breaker bar (3), and a torque wrench (2).

Tighten: Torque the large retaining clamp (1) to 176 N.m (130 lb ft).
